Welcome to the 1st edition of the HP LaserJet Product Update Customer Newsletter—created for our most valuable HP partners and customers. Our intent is to provide you with “hot-off-the-press” technical information about the HP LaserJet printers that you use and support.

This issue provides firmware, software, and hardware updates for the many new HP LaserJet products we introduced in 2005. Let us know what other information would be valuable to you! Write to [ljnewsletter@hp.com](mailto:ljnewsletter@hp.com) and tell us what you think!

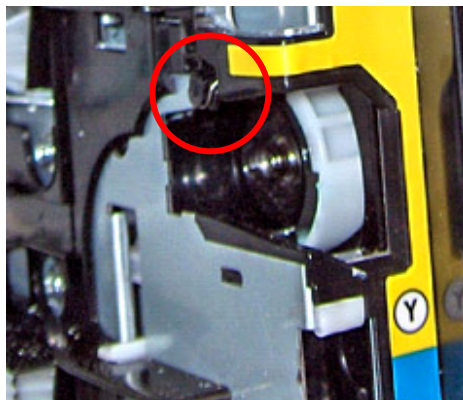
This cartridge locking tab is in place

1. Open and close the front door.
2. Reseat all the cartridges.
3. Power cycle the printer.
4. Look to see if the cartridge lock is broken or in place (see the photos below). If broken, or if steps 1 through 3 did not resolve the issue, contact HP Customer Care and reference document number C00642453.

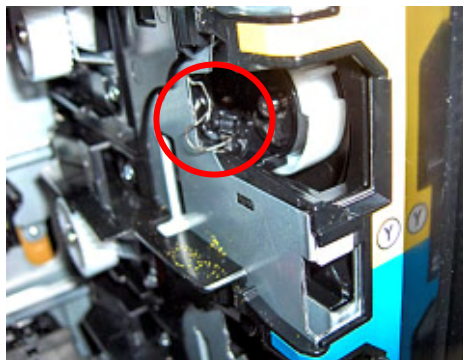
This cartridge locking tab is broken

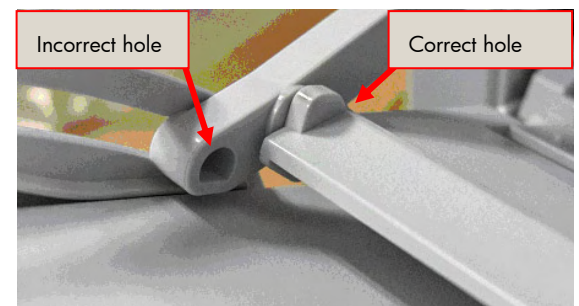
After repairing one of the HP Color LaserJet 3000/3600/3800 series printers, tray 1 may not close properly. To resolve this problem, check the location of the tray 1 inner tray connection. Place the tabs in the second hole, not the first hole, as in the photo below.

Location of the correct inner tray connection

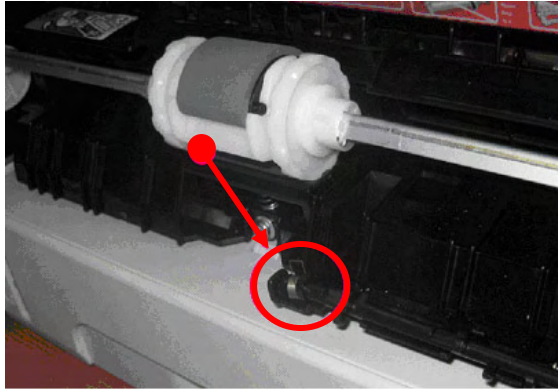
The spring on the manual tray paper presence sensor has come off, as shown in the photo below.

#### The spring is off

Open the front cover. Remove the ETB. Move the sensor flag into the upright position and place the spring behind the sensor flag. If the spring is missing, contact HP Customer Care for repair and reference document number C00715232.

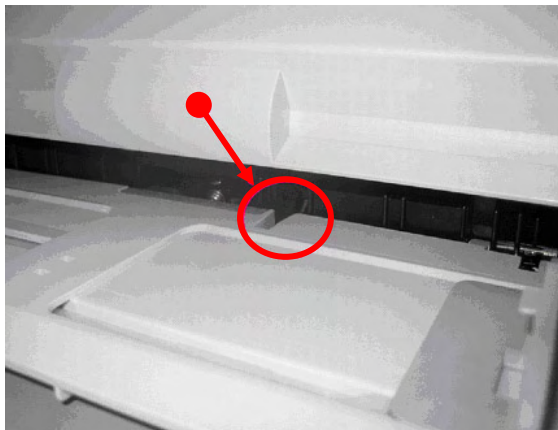
This causes the sensor flag to fall into the sensor path, indicating that paper is loaded into the manual tray (see the photo below). The spring needs to be moved behind the sensor lever.

#### The sensor flag is in the sensor path

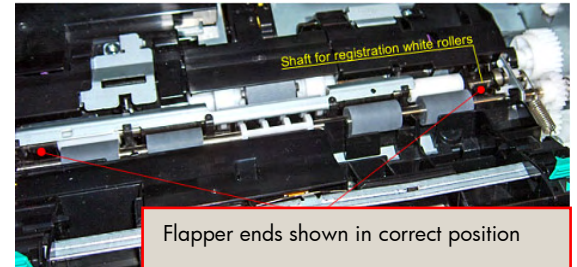
1. Open the front cover and remove the magenta cartridge to expose the Pickup Assembly. Verify if either end of the flapper is dislodged or stuck.

#### Both flapper ends are in front of the shaft

If the flapper is dislodged or stuck, contact HP Customer Care to initiate a repair.

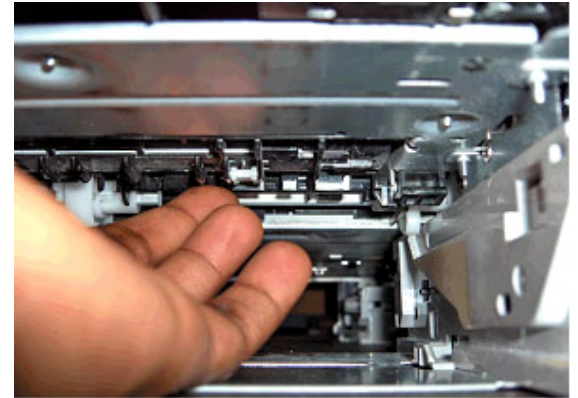
2. Remove tray 2. Reach in under tray 2 and verify if the flapper is able to move back and forth as shown below.

#### Moving the flapper under tray 2

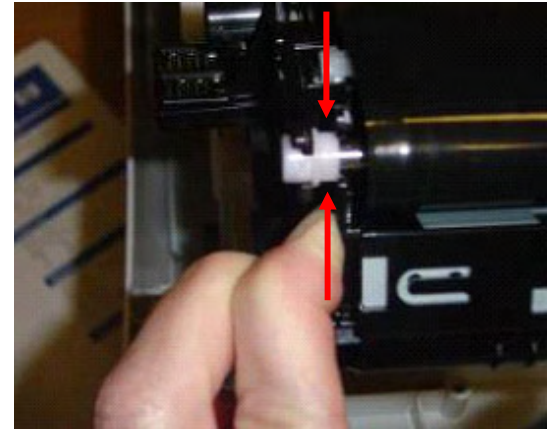
1. Print the event log for the HP Color LaserJet 3000/3800 or look at the event log on the HP Embedded Web Server (EWS). For the HP Color LaserJet 3600, look at the event log in HP Easy Printer Care. If the log file has many 54.01 errors, service is required. Contact HP Customer Care and refer to document number C00642435.
2. Open the front door and check if the black plastic part is on the white plastic bushing on the ETB left-hand side. See the photos below.

**Incorrect position**

3. You can simply snap this piece into place if it is not on the white bushing.

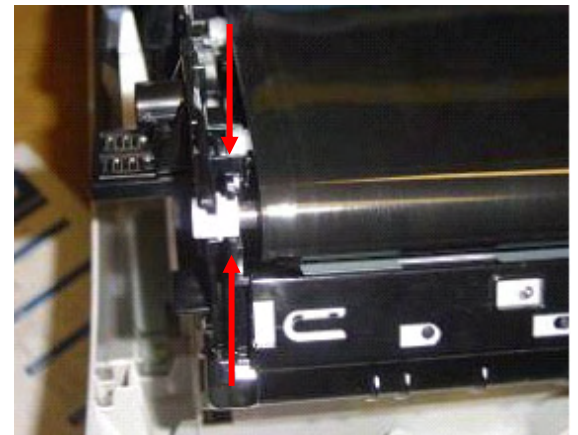
**Correct position**

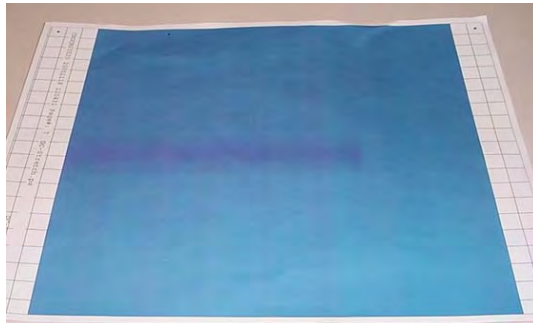
You may, on a rare occasion, experience a dark magenta band in the middle of your halftone or solid fill cyan page (see the photo below).

### Example of magenta band

The printer will require repair. Contact HP Customer Care and refer to document number C00642440.

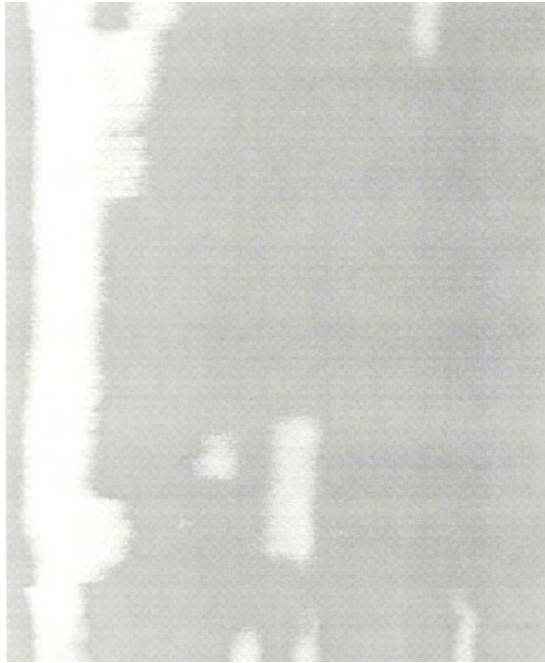
You may experience an odd-looking print quality defect when printing in monochrome mode (see the photo below). Additionally, a 59.F0 error may show in the error log on the HP Color LaserJet 3000/3800 Configuration page or HP Embedded Web Server. For the HP Color LaserJet 3600 printer, view the error log in HP Easy Printer Care.

### Example of monochrome print quality defect

This particular print quality issue/error code is seen only when printing in monochrome mode, and can happen in the middle of a job or at the beginning—any time the engine switches to mono mode. It should rarely occur.

This defect can occur when the DC Controller starts monochrome printing with the Electro-Static Transfer Belt (ETB) in a neutral (non-printing) position. The white strips on the

defective pages are areas where toner does not transfer from the OPC drum to the paper.

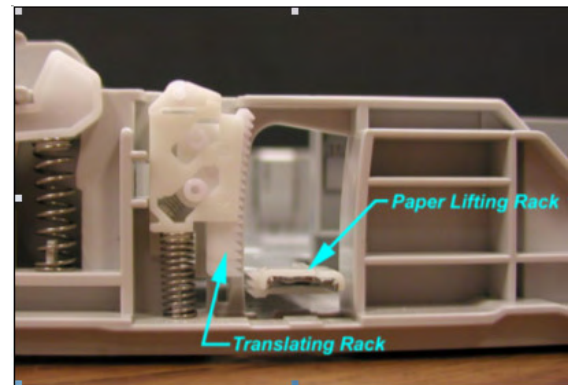
When the tray is removed from the engine, the paper-lifting rack should be in the down position (as shown in the photo below).

Paper-lifting rack in the “down” position

Once it reaches this position, it is latched in this position—allowing you to load the tray. Be sure to *gently* re-insert the tray.

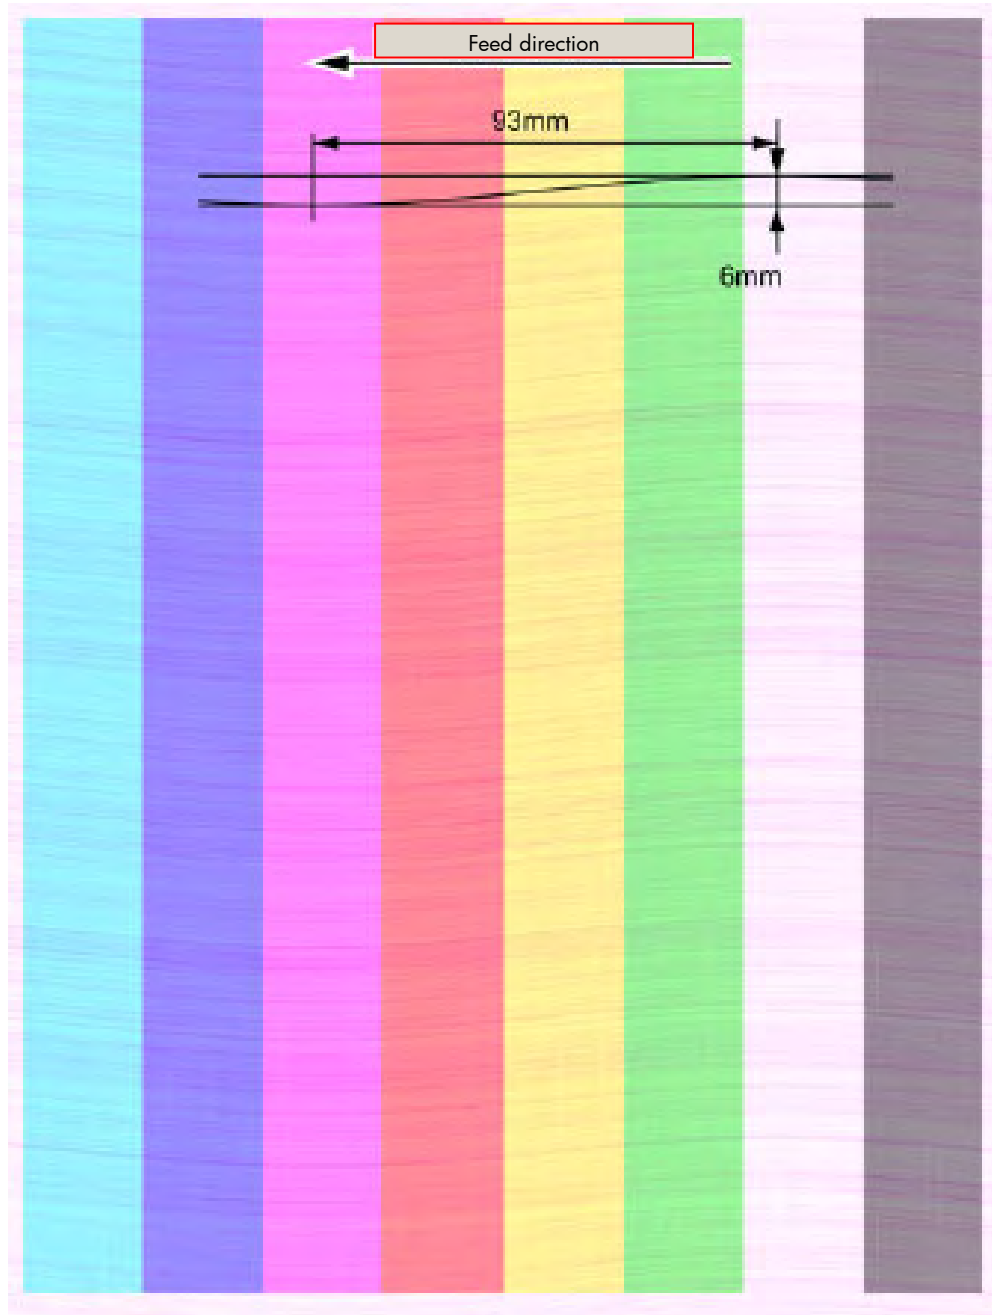
Customers have reported instances of wavy brush marks, or background, seen in a single color or multiple colors on the printed page.

The wavy brush pattern may be seen as a single primary color covering the whole page—including the unprintable region—or just along one edge of the printed page. The issue may also be seen as a full-page background haze in one color, and the wavy pattern may not be apparent. See the sample below.

Example of wavy brush marks

1. Print a Print Quality Assessment set to isolate a particular color plane (magenta in the sample case above).
2. Reseat the image drum matching the wavy brush pattern color.
3. Check the lot code of the toner cartridge for the color(s) exhibiting the defect. If the cartridge is not in the ranges listed in the table below, replace both the toner and drum cartridges to resolve the issue.

In the rare case that background brush marks or dunes continue after installing a print cartridge with a lot code listed in the table above, replace the defective image drum and print cartridge, then contact HP Customer Care for further assistance.
