November  
2006  
Issue 2

Welcome to the 2nd edition of the HP LaserJet Product Update Newsletter—created for our most valuable HP partners and customers. Our intent is to provide “hot-off-the-press” technical information about the HP LaserJet printers you use and support.

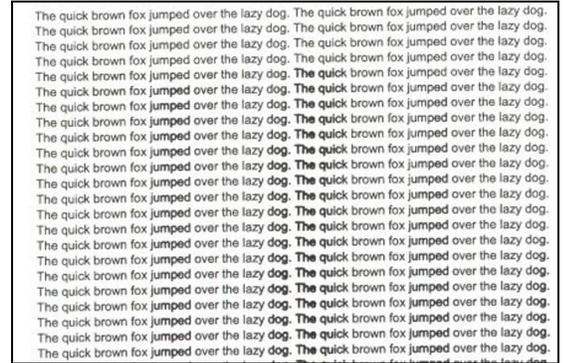
The unusual pattern of random, dark characters appearing in the text (see the sample to the right) results from light leaking into the print cartridge cavity. In our sample case, the multi-purpose tray (Tray 1) had been left open with the Envelope Feeder blanking cover removed.

Sample of print quality defect

To prevent this print defect from occurring, close the multi-purpose tray, and/or re-install the blanking plate.

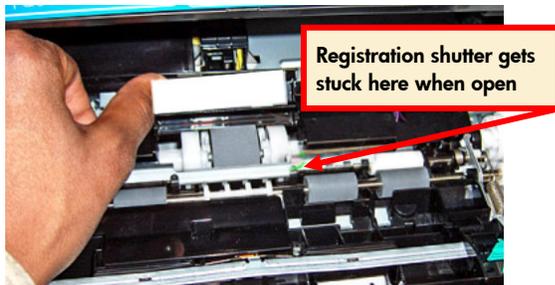
The dislodged cam claw causes the pick-roller assembly to move further to the right. This in turn causes the registration shutter to get stuck in the open position (the shutter gets stuck on the side of the pick-roller). See the photo below.

**The pick-roller assembly has moved to the right**

Open the front door and remove the print cartridges. See if the pick-roller has moved to the right and is interfering with the one edge of the registration shutter (as shown in the photo above). If this is the case, contact HP for technical support. A service technician is required to replace the pick-up assembly.

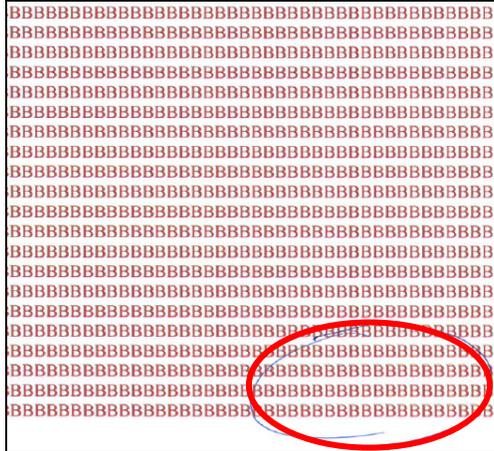
Customers may experience a Color Plane misregistration in the process direction (top to bottom of the page as it comes out of the printer). The image may appear blurry, and can occur anywhere on the page, but most often appears in the lower portion of the page (see the example below).

Example of a blurred image

1. Ensure that you have the latest DC controller and formatter firmware installed. You may download these files from the following URLs:  
[www.hp.com/support/CLJ3000](http://www.hp.com/support/CLJ3000)  
[www.hp.com/support/CLJ3600](http://www.hp.com/support/CLJ3600)  
[www.hp.com/support/CLJ3800](http://www.hp.com/support/CLJ3800)
2. From the control panel of the printer, perform three full calibrations in a row. Print out a page after each calibration to see if there is any improvement.
3. If this does not solve the issue, reseal the fuser. Open the top cover, pinch in at the blue marks, and lift up on the fuser. Set it back down into place and press firmly to make sure it is level and seated. Close the cover.
4. If the steps above did not solve the issue, contact HP for technical support.

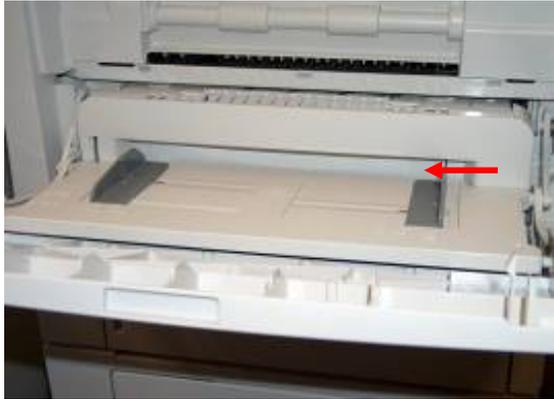
One possible cause for these errors is that the Tray 2 cassette shutter is not opening when Tray 1 opens. This shutter must open in order to allow paper to feed through the Tray 2 cassette when printing from Tray 1. (See the photos below.)

Tray 2 shutter closed (incorrect)

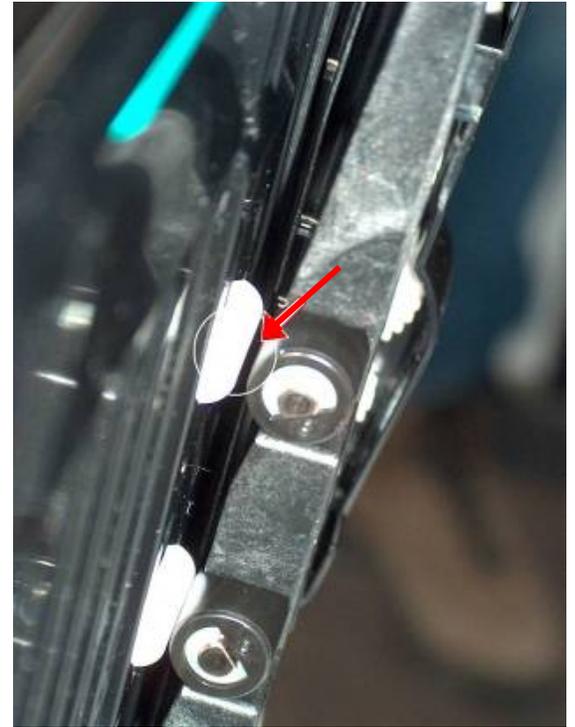
Make sure the duplexer roller plate is installed on the back of the ETB. Duplex printing cannot be performed without the duplexer roller plate. Verify that the plate is sitting flush to the ETB and not out like the photo top, right.

### Incorrect position—gaps between the rollers

Make sure there are no gaps between the rollers. Re-install the plate if necessary.

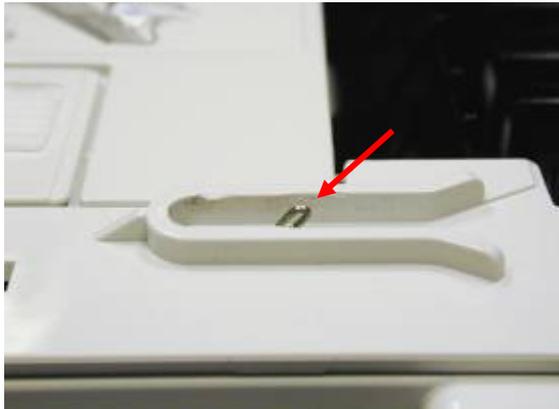
Deformed or bent grounding spring

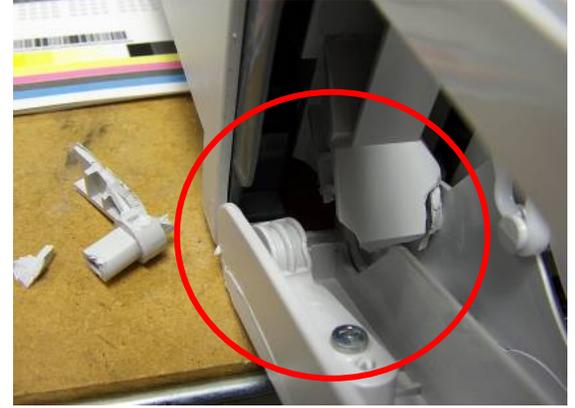
Open the front door (not the multi-purpose tray) and inspect the left hinge. If it is damaged, you will need to replace the printer.

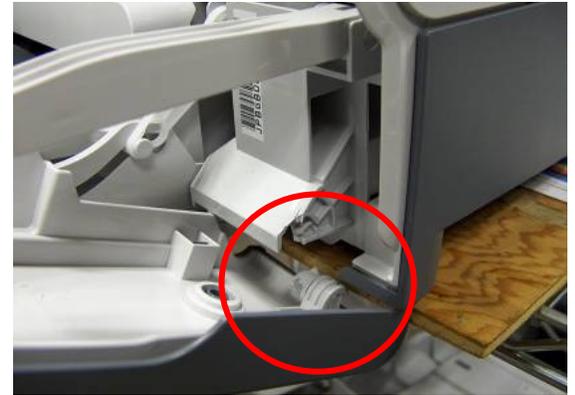
Open the front door and inspect the right hinge. If it is damaged, you will need to replace the printer.

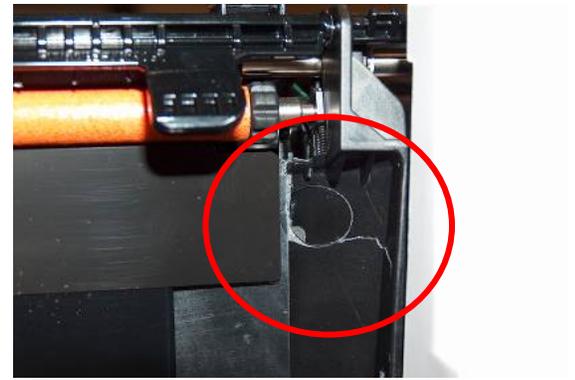
Inspect the exit roller area (if ph+, remove the stapler/stacker). If it is damaged, you will need to replace the printer.

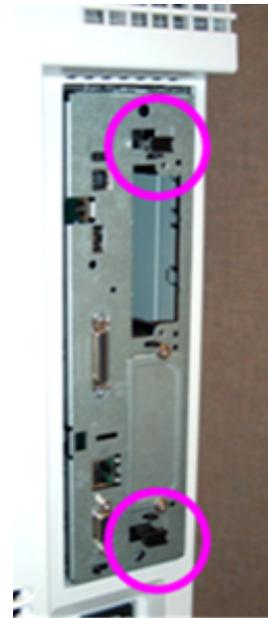
During shipping, the formatter may vibrate loose. When this occurs, the control panel display will be blank. Other symptoms may occur if the formatter is loose, but not completely disconnected.

Incorrect position

In the photo on the preceding page, the levers are in the innermost position (towards the center of the formatter=not locked) and the formatter is not recessed .25 inch (6–7 mm) from the side cover. The correct position is shown below.

3. Power off and reseal the formatter by slowly but firmly pressing the formatter into the printer. When you hear the black formatter lever locks “click” into place, continue to firmly press the formatter into the printer for another 5 - 6 mm until the formatter stops. Make sure the formatter is **NOT** flush with the cover, but, rather, recessed roughly 5 - 6 mm and the formatter levers are in their outermost (locked) position.

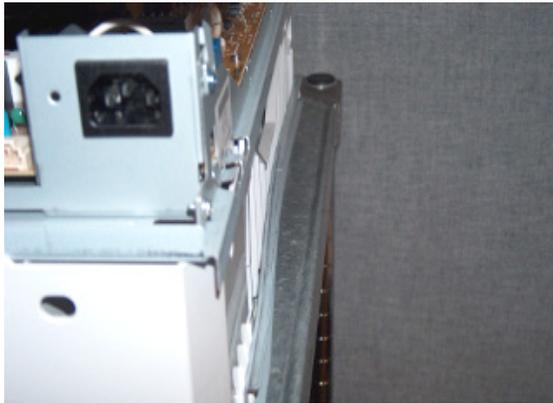
The printer may have experienced mild damage during shipment—for example, the rear crossbar on the chassis (behind Tray 2) may bow inward, pushing Tray 2 slightly forward and out of a completely inserted position. See the photos on the next page.

The rear cover is removed, showing that the crossbar on the chassis is bowing inward more than normal

3. Reach under and behind the rear cover, feeling for the metal crossbar. Using the other hand or shoulder to brace against the printer, carefully pull the crossbar outward, being VERY careful to keep the printer from sliding off the table. See the photo below.

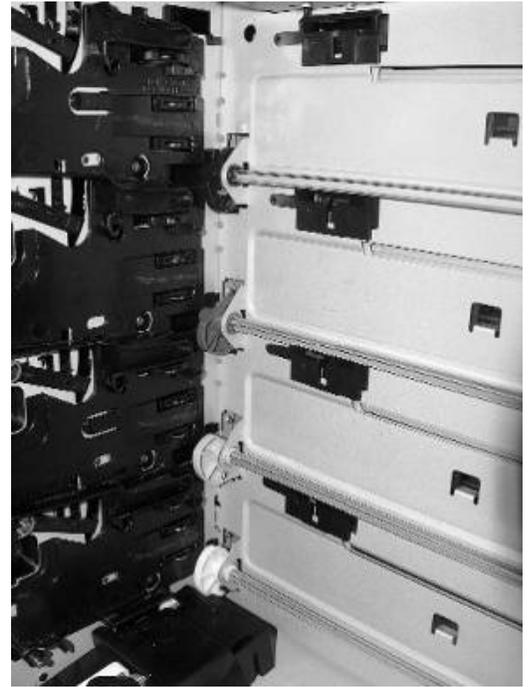
More often, the secondary alienation (SCIP) cams may catch on the back side of the sheet metal at the rear of the cartridge atrium. This prevents successful SCIP cam “roll over.” Because these cams are caught behind the back-side of the sheet metal, the Developer Disengaging Motor will stall and make a pulsating grinding noise. See the photo on the right for the position of the cams when this occurs.

Typical developer alienation SCIP cams in “stall” position, with at least one SCIP cam stuck (left-side Developer Alienation Cams shown)

1. Power up and verify the 59.C0 error message and pulsing /grinding noise.
  2. Open and remove the ETB and 4-cartridges.
  3. Check the left side and right side Developer Alienation cam position and verify that secondary alienation (SCIP) cams are not visible after unsuccessful “rollover.”
-

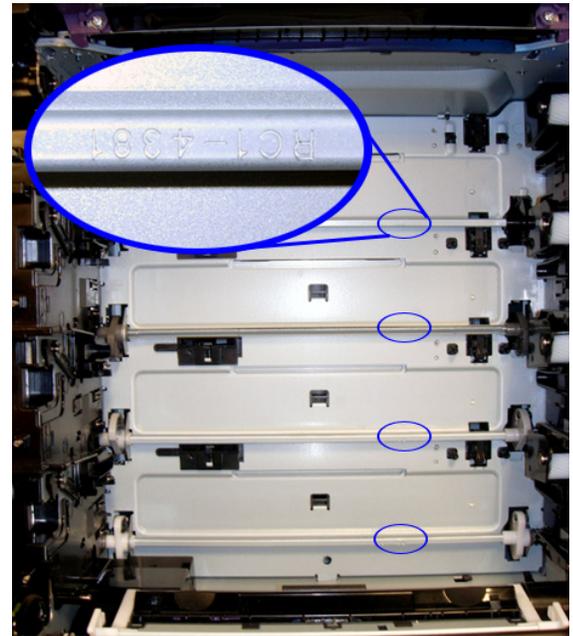
In the illustration on the right, the black (K) cartridge developer disengaging cam rod is correctly positioned, but the magenta developer disengaging cam rod (2<sup>nd</sup> from top) is improperly timed as the “face” of the rod is rotated out of position compared to the other three.

**Top (black – K) rod correctly positioned  
Second (magenta – M) rod incorrectly positioned**

1. Remove four screws (callout 1).
2. Remove the developer disengaging drive assembly (callout 2).

3. Locate the four developer disengagement cam gear positions (callout 3). Each developer disengaging cam has a corresponding gear. Rotating these gears will rotate the disengaging cam rod, allowing for timing adjustment.

- 
- Each timing gear has an indicator “pin” (callout 4) that must be aligned with the timing mark (callout 5) stamped on the printer’s chassis. Align all four timing gears.

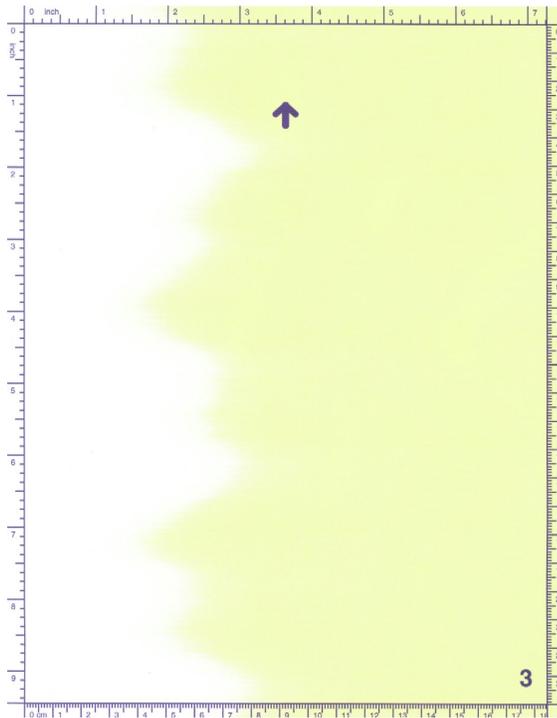
We have had some reports that the yellow cartridge is not engaging or disengaging properly, resulting in a partial or missing yellow color plane. This is seen as a fade from right to left on the yellow Print Quality Troubleshooting page. In addition to the misalignment of the main drive assembly gears, this phenomenon can also be caused by improper reinstallation of the paper feed assembly cable cover in the cartridge atrium.

### Example of yellow not engaging

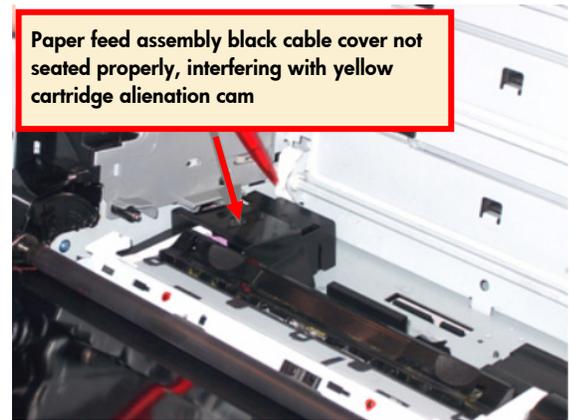
Paper feed assembly black cable cover not seated properly, interfering with yellow cartridge alienation cam

The cable cover is not seated properly
