November  
2007  
Issue 5

Welcome to the HP LaserJet Product Update Newsletter. We begin this newsletter with up-to-the-minute news concerning three critical product and process updates. They are highlighted here for your immediate attention:

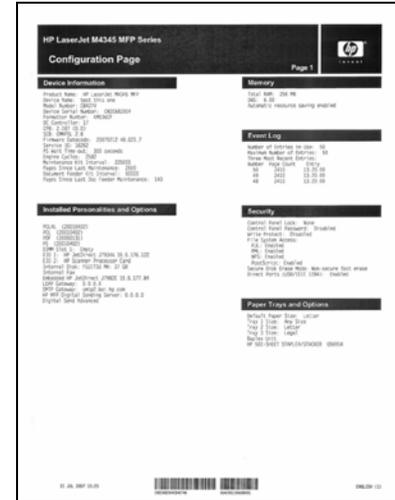
First printed page

When copying a multiple page document from the ADF, the first page is the proper density but the second and all remaining pages are light. This same problem occurs differently when scanning to folder or scanning to email: the first page is the proper density and hue but the second and all remaining pages show a color shift. Black text becomes magenta or sometimes is reversed to white. Some black areas turn magenta while the background changes from white to cyan.

This issue is caused by a misregistration of the scan head and the secondary gain calibration patch. The scan head reads the primary gain patch at the start of every scanning operation. It then moves to the ADF scan port and the page is scanned. If multiple page documents are scanned through the ADF, the scan head reads the primary gain patch, moves to the ADF scan port location and makes the first copy. The scan head then remains in position at the ADF port and reads the secondary gain patch before scanning each additional page. If the scan head registration is slightly off in relation to the gain patch, the gain compensation for the scan will be off and the second through  $n$  pages will be light or have a color hue shift, depending on the amount of gain patch misregistration.

This issue can be resolved by running the “Calibrate Scanner” routine located in the Troubleshooting or Diagnostics menu, depending on the MFP model. If calibrating the scanner fails to resolve the issue, contact HP Customer Support for assistance.

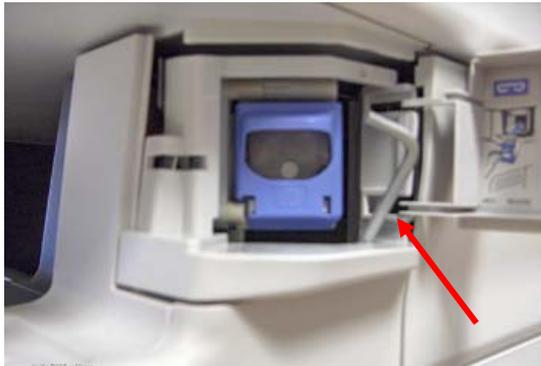
During transportation of the HP Color LaserJet M3035 MFP series, the stapler actuator rod frequently comes off. The stapler will not work and you may think it is broken. You may repair this yourself using the following instructions, or contact HP Customer Support for assistance.

The actuator rod is out of place

1. Open the stapler door and grab the stapler actuator rod using needle nose pliers (or by hand) and insert the actuator rod back into place.

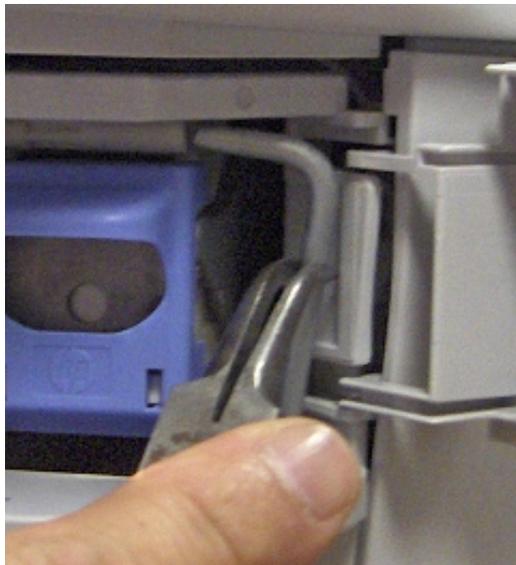
Reposition the actuator rod

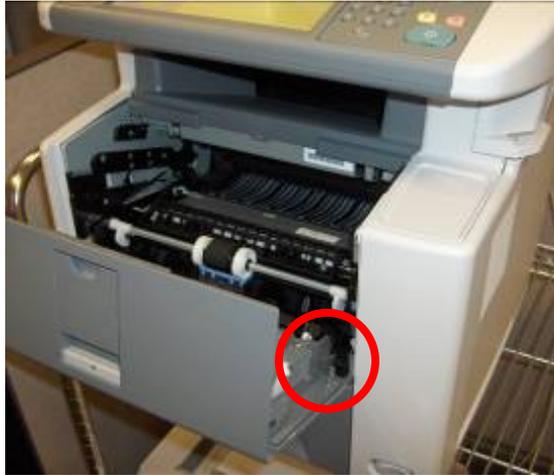
### Location of dislodged plastic arm

The white plastic arm that connects the cam mechanism to engage and disengage the driver for the toner cartridge may come off during transportation, making it impossible to install the toner cartridge. Use the following instructions to reconnect the plastic arm.

1. Open the front cartridge door. Use needle nose pliers to grab the white plastic arm and insert it back into place (this can also be done by hand).
2. Verify that the plastic arm is installed properly by opening and closing the cartridge door and installing and removing the toner cartridge two or three times. The engine should run smoothly thereafter.

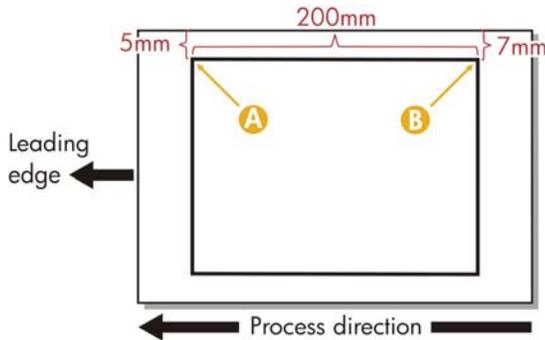
From point A to point B, the margin measures 200 mm, multiplied by 0.01 gives 2 mm as the target specification. The distance from point A to the edge of the paper is 5 mm and the distance from point B to the edge of the paper is 7 mm. This difference of 2 mm is considered within specifications.

- Adjust the paper guides on the ADF input tray until they are snug against the media.
- VERY IMPORTANT: Verify that the ADF input tray is properly seated and not misaligned. The plastic tabs that keep the tray in place may be broken.

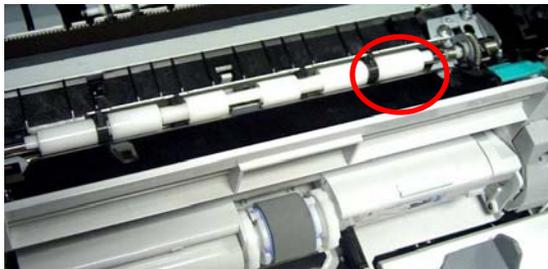
Photosensor PS112

PS112 is the only photosensor in the 4345mfp and M4345 MFP that can not be tested via the Manual Sensor test or the Paper Path Sensor test from the control panel. PS112 senses media that is narrower than 7.4 inches (188 mm) as well as residual media present in the paper path. Diagnosing a failure of this sensor can be difficult and time consuming. The process can be made easier by understanding the sensor's failure modes and the appropriate troubleshooting procedures.

PS112 is a photosensor actuated by a flag. Photosensors have two failure modes. The photosensor is made up of two components, a light emitting diode and a receptor. If the diode fails, it behaves like the flag is engaged; the light path is always occluded. If the receptor fails, it behaves like the flag is never engaged; the light path is always open.

We have seen instances where the PS112 sensor fails because of toner buildup in the sensor. In the cases we have investigated, this is due to toner dumping caused by remanufactured toner cartridges. We have had success resolving the failure by blowing out the sensor using compressed air.

The page width sensor PS112 is part of the central printer block. This part is not replaceable. If the PS112 fails the entire printer must be replaced.
