October 2006
Issue 32

Welcome to the 32nd edition of the HP LaserJet Product Update Newsletter—created for our most valuable HP partners and customers. Our intent is to provide “hot-off-the-press” technical information about the HP LaserJet printers you use and support.

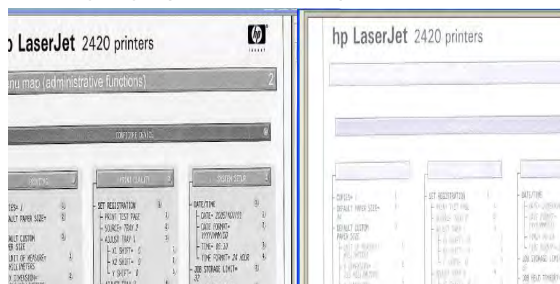
When a cartridge prints with extremely light print from the beginning, it typically indicates a print cartridge problem. Text characters and grayscale images or backgrounds may be noticeably lighter. Solid black areas on the page, such as boxes or logos, may appear to be a light gray. See the comparison below.

Comparison between normal print and extremely light print.

Warranty replacement of the cartridge is recommended.

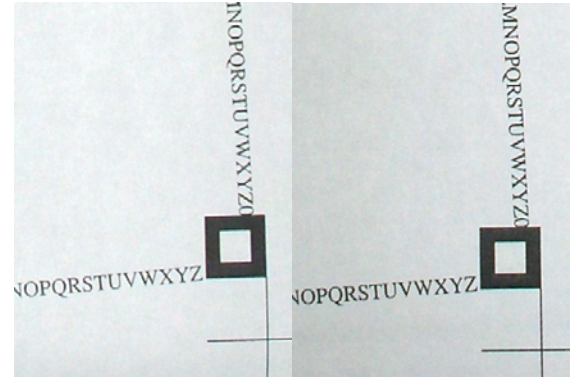
be lighter. In this case, the text on a page is of uniform darkness and the lines may appear to be thinner. Any grayscale images or background on a page may appear to be slightly lighter. Solid black areas should appear dark. See the example below—the solid areas are dark, but the characters are thinner.

Examples of thin print

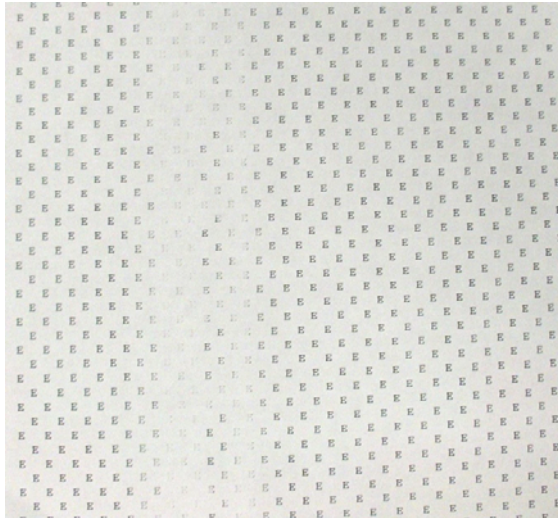
When a monochrome print cartridge reaches end-of-life, the print will sometimes begin to fade as the toner in the cartridge is depleted. When this fade starts to occur, the print on the pages will begin to lighten. Typically, the lightness is not uniform across the page. Some areas of the page appear to be lighter than others. As pages are printed, the faded area will get bigger. See the sample below.

Example of faded print

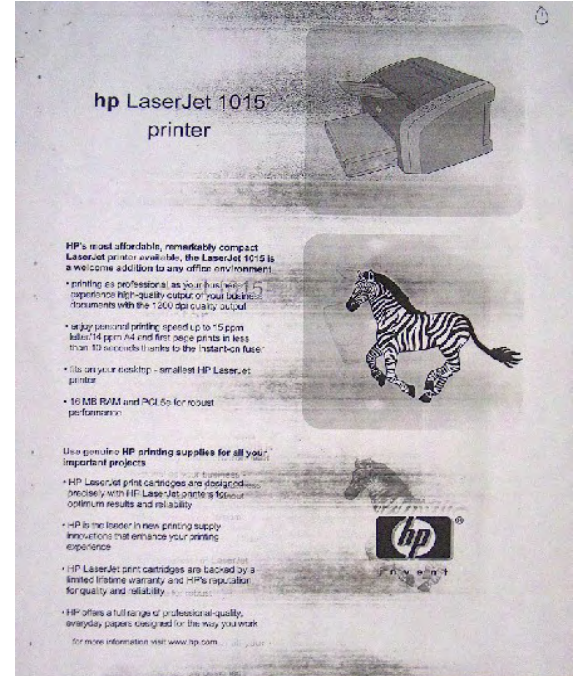
We have discovered a defect for the print cartridges listed in the table on the following page. The Primary Charge Rollers (PCRs) are not charging the Organic Photo Conductor (OPC) drum correctly. This improper charging causes smudges on printed output repeating at the pitch of the PCR—about 38 mm. It is more noticeable on black and grayscale pages. On some cartridges, the "ghost" of text or images may repeat down the page at the OPC pitch. See the print sample below.

Print sample with ghost images

The cartridges with a lot code that begins with a number greater than "5J" should be replaced under warranty. Refer to the table below for the defective print cartridge numbers.

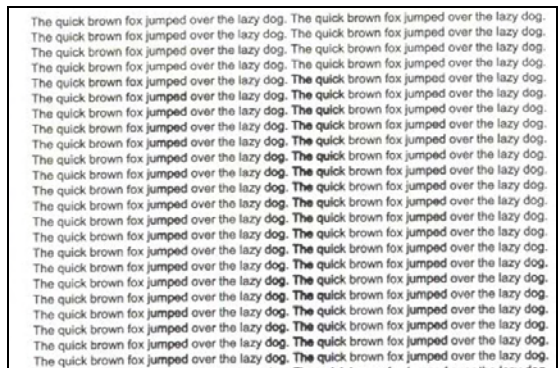
The unusual pattern of random, dark characters appearing in the text (see the sample below) results from light that is leaking into the print cartridge cavity. In the case of the sample below, the multi-purpose tray (Tray 1) had been left open with the Envelope Feeder blanking cover removed.

Sample of print quality defect

To prevent this print defect from occurring, close the multi-purpose tray, and/or re-install the blanking plate.

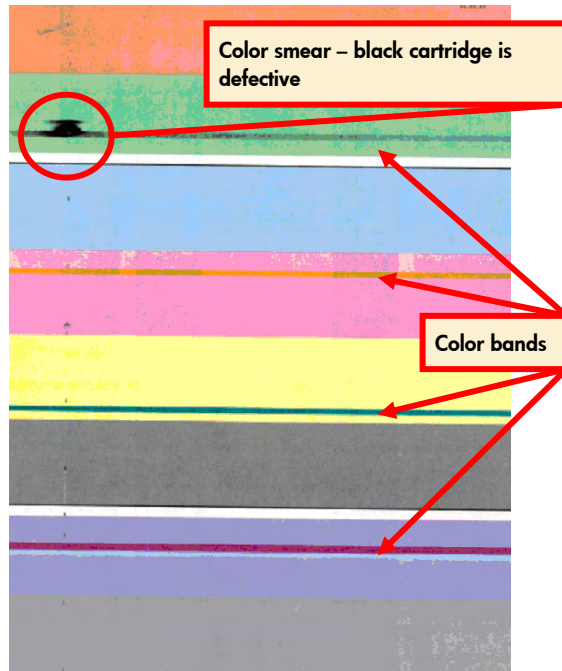
These bands are caused by damage to the Organic Photo Conductor (OPC), creating an electrical “leak” in the drum on one of the print cartridges. Because the OPCs for all four cartridges share a common power supply, when one of the OPCs is damaged, the defect shows up on all four colors. You can identify the damaged cartridge by a color smear on the line associated with the cartridge. For example, damage to the black cartridge can be identified by a black smear on the black line of the page. See the example below.

Example of defective black cartridge

The damaged cartridge should be replaced. It is not necessary to replace all four cartridges. Determine which cartridge to replace by locating the smear on the line.

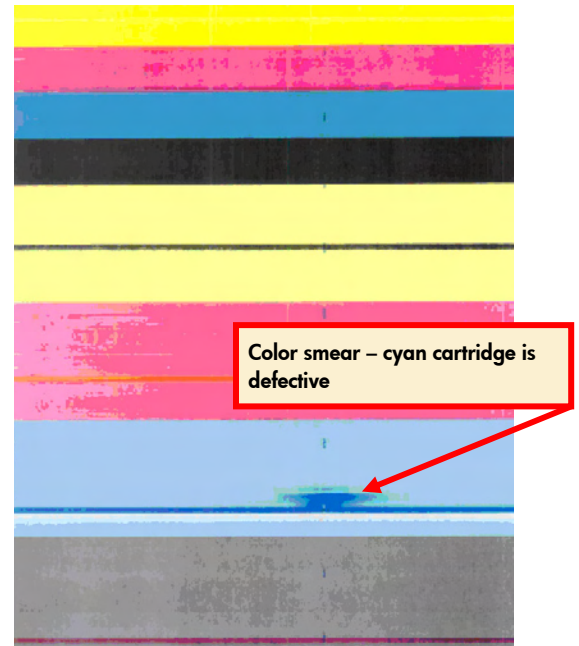
Example of defective cyan cartridge

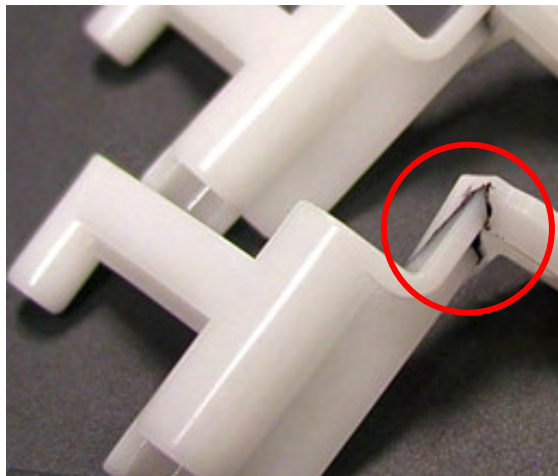
- Reseat all the cartridges.
- Check for a broken part that controls the movement of the cartridge engagement arm, the cartridge shutters, and the Organic Photo Conductor (OPC) drive (see the photos below). The first photo shows where the break occurs. The second photo shows where this part is located. You can easily check this without taking off the covers by reaching over to the white rod arm on the right hand side of the ETB, and wiggling it. If it moves easily, the part is broken. Replace with part number RC1-6645-000CN.

Area where break occurs

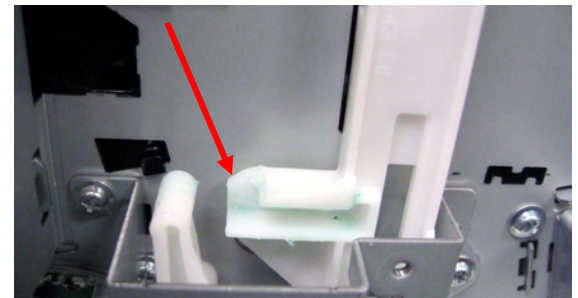
Check the slide lever

Also, check to make sure the slide lever itself is not broken (see the photo below). If it is, replace it with part number RC1-6643-000CN. To replace these parts, refer to the instructions in the Cartridge Lock Service Note.

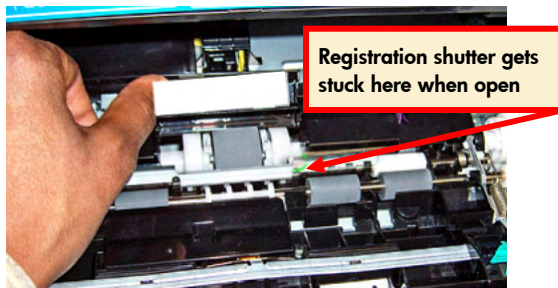
A customer may experience a 13.20 paper jam message, but not be able to find a paper jam. Alternatively, the customer may say that paper seems stuck in the fuser (protruding about 1 inch out of it) causing a 13.02 error message. We have noticed that the pick-up assembly's (PIU) left cam's holding claw may come dislodged, causing the pick roller assembly to move further to the right, which in turn causes the registration shutter to get stuck in the open position, creating jams. (The shutter gets stuck on the side of the pick roller.) See the photos below for more details.

The pick roller assembly has moved to the right

Have the customer open the front door and remove the print cartridges. See if the pick-roller has moved to the right and is interfering with the one edge of the registration shutter (as shown in the first photo). A service technician is required to replace the pick-up assembly (see the part numbers below).

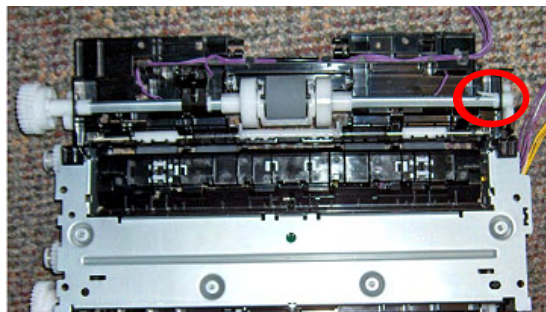
Pick-up assembly with lifted flange circled

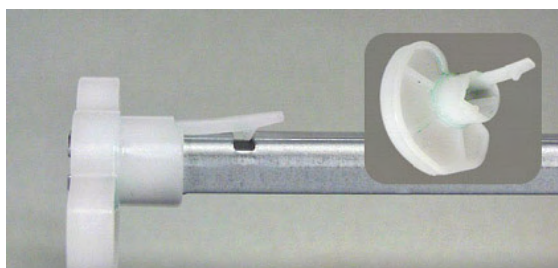
We suspect that the long tip of the left cam became bent, causing the holding claw to dislodge from the pick-roller shaft. Without the holding claw in place, the pick-roller assembly can shift to the right and interfere with the registration shutter (see the photo below).

Dislodged holding claw

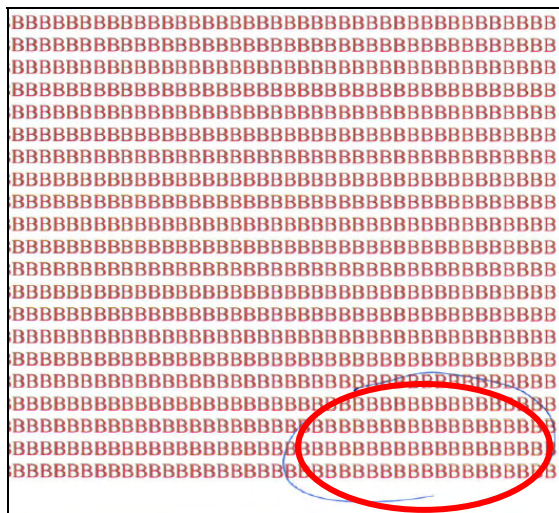
Customers may experience a Color Plane misregistration in the process direction (top to bottom of the page as it comes out of the printer). The image may appear blurry, and can occur anywhere on the page, but most often appears in the lower portion of the page (see the example below).

Example of a blurred image

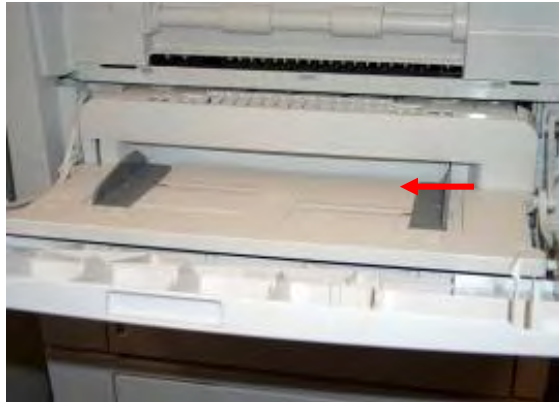
One possible cause for these errors is that the Tray 2 cassette shutter is not opening when Tray 1 opens. This shutter must open in order to allow paper to feed through the Tray 2 cassette when printing from Tray 1. (See the photos below.)

Tray 2 shutter closed (incorrect)

Have the customer remove the front cover from Tray 2 and examine the shutter mechanism by following the steps in the next column.

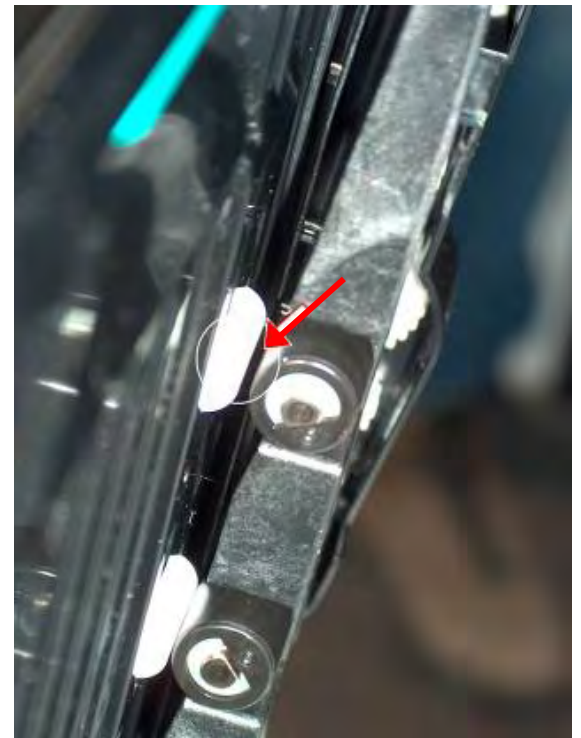
Duplex printing cannot be performed without the duplexer roller plate. Verify that the plate is sitting flush to the ETB and not out like the photo below. Re-install the plate if necessary.

Incorrect position—gaps between the rollers

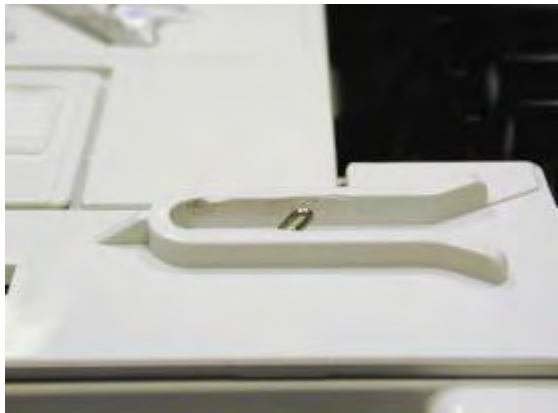
Ask the customer to inspect the cassette ground spring on the right side of the cassette. See the photos below to identify a “normal” or good spring versus a deformed or bent cassette grounding spring.

Deformed or bent grounding spring

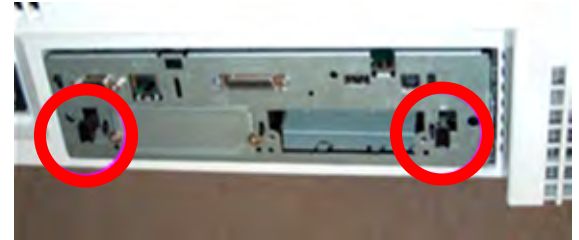
Incorrect

In the photo above, the levers are in the innermost position (towards the center of the formatter—not locked) and the formatter is not recessed .25 inch (6–7 mm) from the side cover.

3. Power off, firmly seat the formatter into the printer, and retest. Make sure the formatter is **NOT** flush with the cover, but set back (recessed) roughly a quarter of an inch (6–7 mm) and the formatter levers are in their outermost (locked) position. (See the photos below.)

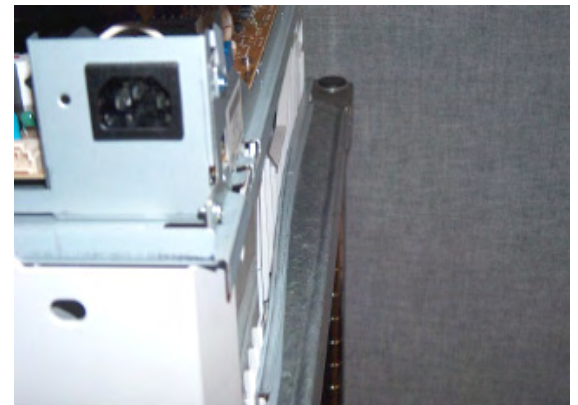
The printer may have experienced mild damage during shipment—for example, the rear crossbar on the chassis (behind Tray 2) may bow inward, pushing Tray 2 slightly forward and out of a completely inserted position. See the photos below.

The rear cover is removed, showing that the crossbar on the chassis is bowing inward more than normal

5. Use one hand to press against the rear of the printer and the other to pull the crossbar straight. See the photo below.

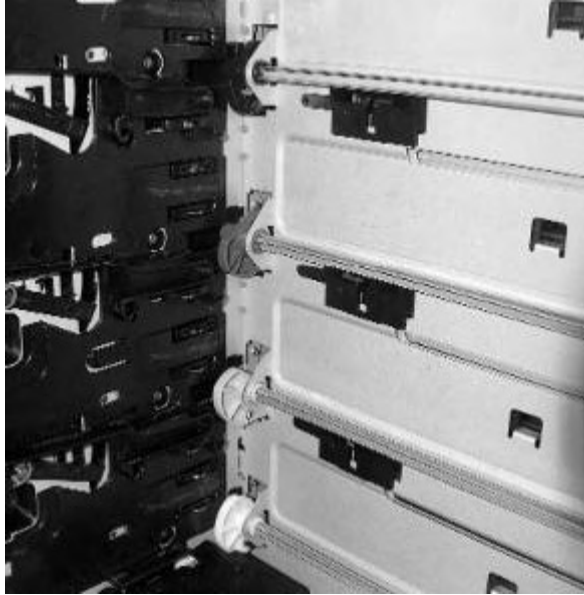
SCIP cams are not visible after unsuccessful roll over

1. Power up and verify the 59.C0 error message and pulsing/grinding noise.
2. Open and remove the ETB and four cartridges.
3. Check the Developer Alienation Cam position and verify that the SCIP cams are not visible after unsuccessful "rollover."
4. On the HP Color LaserJet 4700, remove the right side cover. On the HP Color LaserJet 4730 MFP, remove the rear cover.
5. Manually rotate the Developer Drive Alienation Gear in the *counterclockwise* direction until the SCIP cams pop through the sheet metal hole.

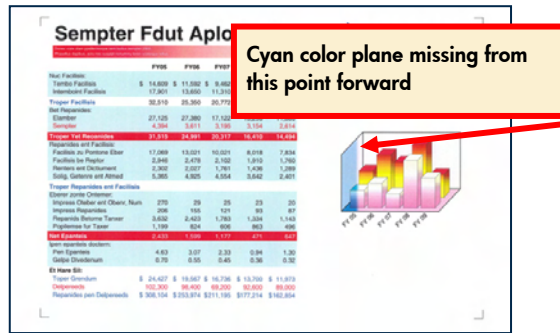
Customers may report that a color plane is partially or completely missing from the page.

Partial color plane (cyan)

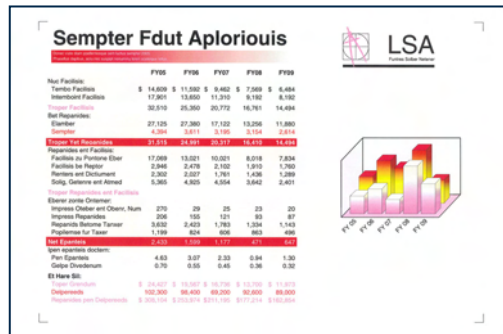
Missing color plane (cyan)

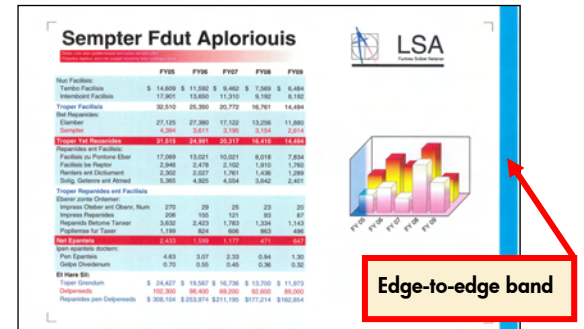
Customers may report an intermittent print quality defect where edge-to-edge bands appear on a page, on the back of a page, or on the ETB in a single color. Alternatively, customers may report light and dark bands on the page which are not edge to edge. These bands will appear as a light band (toner missing) followed 20 mm's later by a dark band (extra toner). See samples below.

Edge-to-edge band in single color

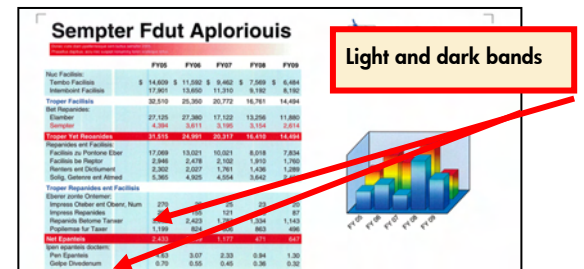
Light and dark bands on page (at 20 mm offset)

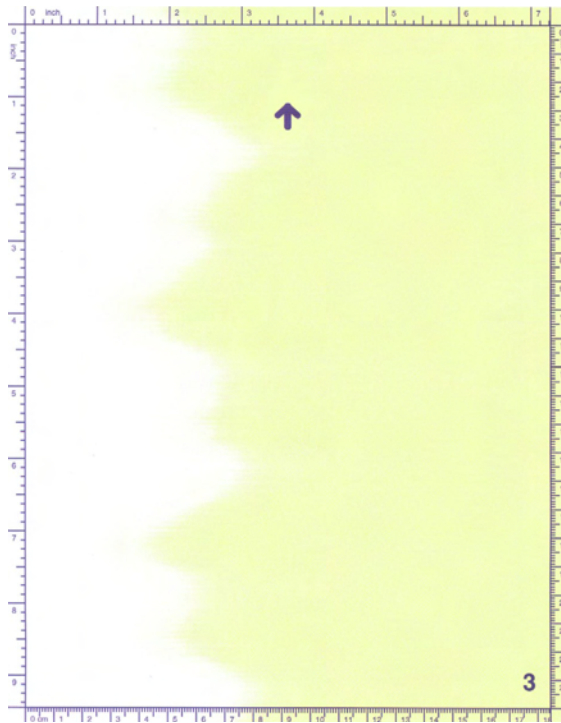
We have had some reports that the yellow cartridge is not engaging or disengaging properly, resulting in a partial or missing yellow color plane. This is seen as a fade from right to left on the yellow Print Quality Troubleshooting page. In addition to the misalignment of the main drive assembly gears, this phenomenon can also be caused by improper reinstallation of the paper feed assembly cable cover in the cartridge atrium.

Example of yellow not engaging

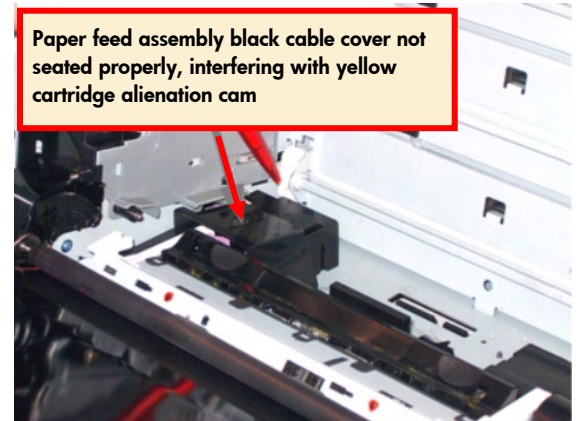
Paper feed assembly black cable cover not seated properly, interfering with yellow cartridge alienation cam

The cable cover is not seated properly
