February
2008
Issue 6

Welcome to the HP LaserJet Product Update Newsletter! Our featured articles, created in response to field and support partner requests, provide technical responses to UPD Frequently Asked Questions and a "BEST PRACTICES" for using HP LaserJet drivers in Microsoft® Cluster Server environments. Please keep sending your valuable comments and questions to ljnewsletter@hp.com.

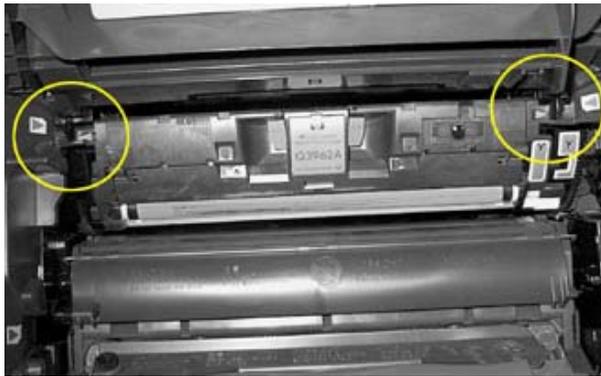
The HP Color LaserJet 2820/2840 All-in-One carousel can become misaligned if the product is dropped or shipped with the toners installed. The misalignment of the carousel will result in print quality issues, typically exhibited by seeing missing print on the left or right half of the paper. Most often, the print is on the left of the page and the right side has no print. This document will demonstrate a method of realigning the carousel gears without removing the scanner top, formatter, and laser scanner.

Yellow toner one gear tooth out of alignment

Notice that the left arrow on the cartridge is slightly more forward than the right arrow. The skew is more pronounced the more the carousel is out of alignment.

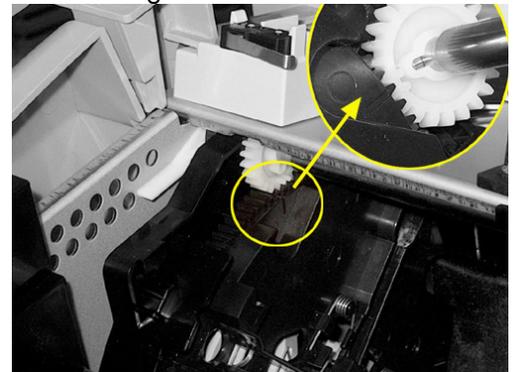
Recess in black gear points between two alignment posts on white drive gear

- 13. Observe the carousel gear mesh in the upper left of the carousel area to verify the alignment. Check that the recess in the large black carousel gear points exactly between the two alignment posts on the white drive gear.

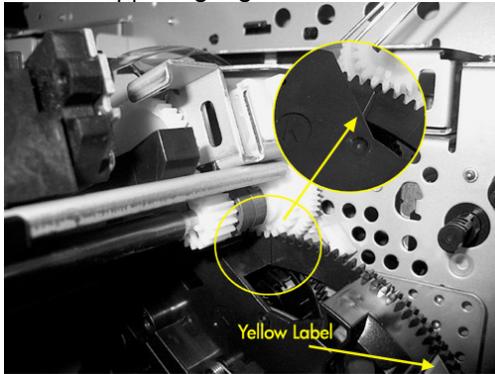
Recess is directly between alignment posts

14. Repeat the alignment verification process with the upper right gear mesh area.

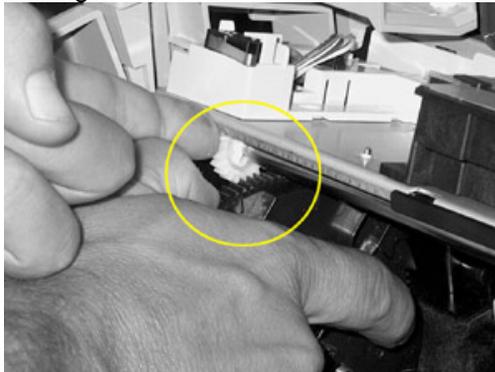
Carefully adjust alignment of gears

15. If misalignment in the right or left sides of the carousel is observed, firmly pull in on the top of the black gear to allow the gear mesh to slip in relation to the white drive gear. Use only enough force to disengage the gears meshing. Too much force will deform sheet metal or possibly break the black gear. Move the white gear, one tooth at a time, in a direction that will position the recess in the black gear directly between the alignment posts on the white gear.
