FB10000 Error Messages Troubleshooting

Error ID: 50017 – Media Handling – L1-axis did not reach its Home position.

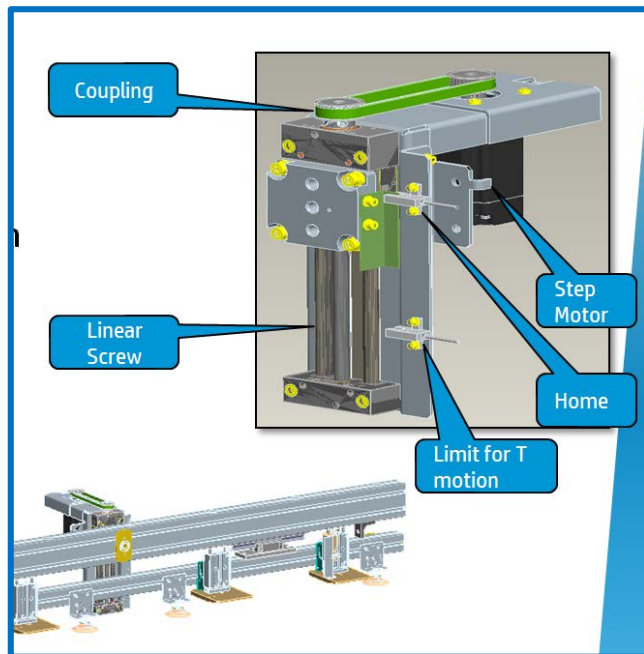
1. Verify that L1 sensor (Limit for T) is properly positioned and not damaged.

2. Verify that L1 (Limit for T) sensor functions properly.
