FB10000 Error Messages Troubleshooting

Error ID: 50080: M-Handling – Manual loading pins are unable to go down

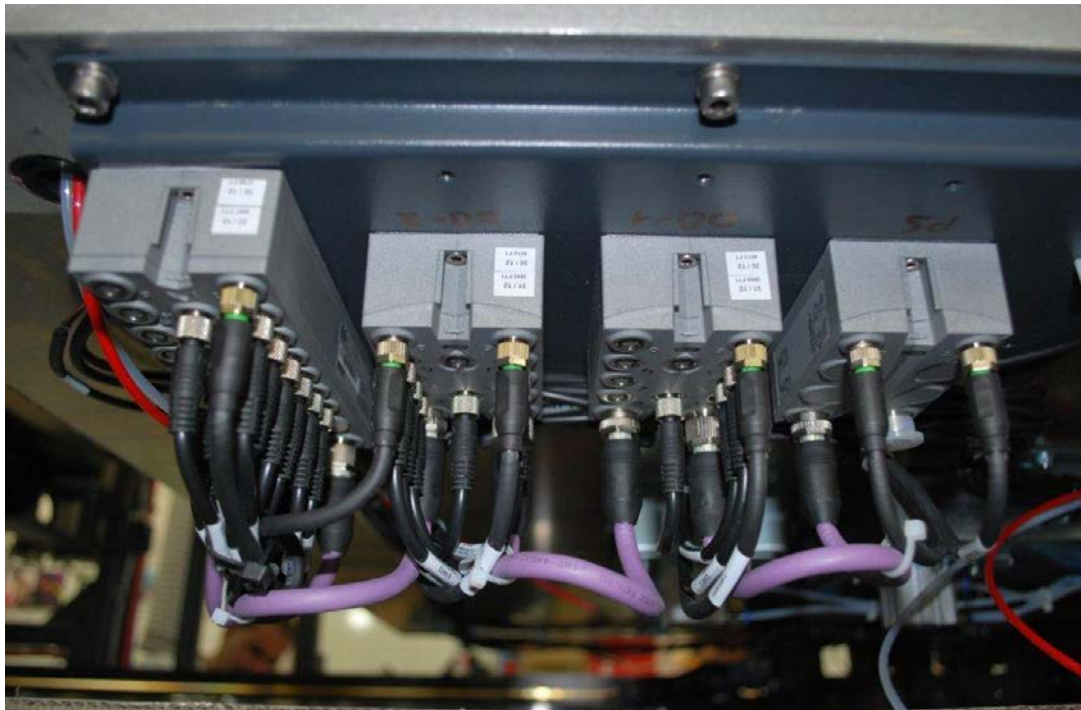
One of the loading pins sensor is disconnected or faulty

1. Open Control Tools and activate the three front positioning pins while you monitor their movement (Bug in Control Tools – always show 4)
2. Repeat this action on the three rear positioning pins while you monitor their movement.
3. Check individually each pin sensor under the table to ensure that they are all properly fixed.
4. Check each of the six positioning pins Molex connectors and ensure they are all tightly attached to the cable leading to the X67 B&R block.
5. Tighten the circular plugs in the X67 B&R block under the table (see X67 B&R Block connections under vacuum table below).

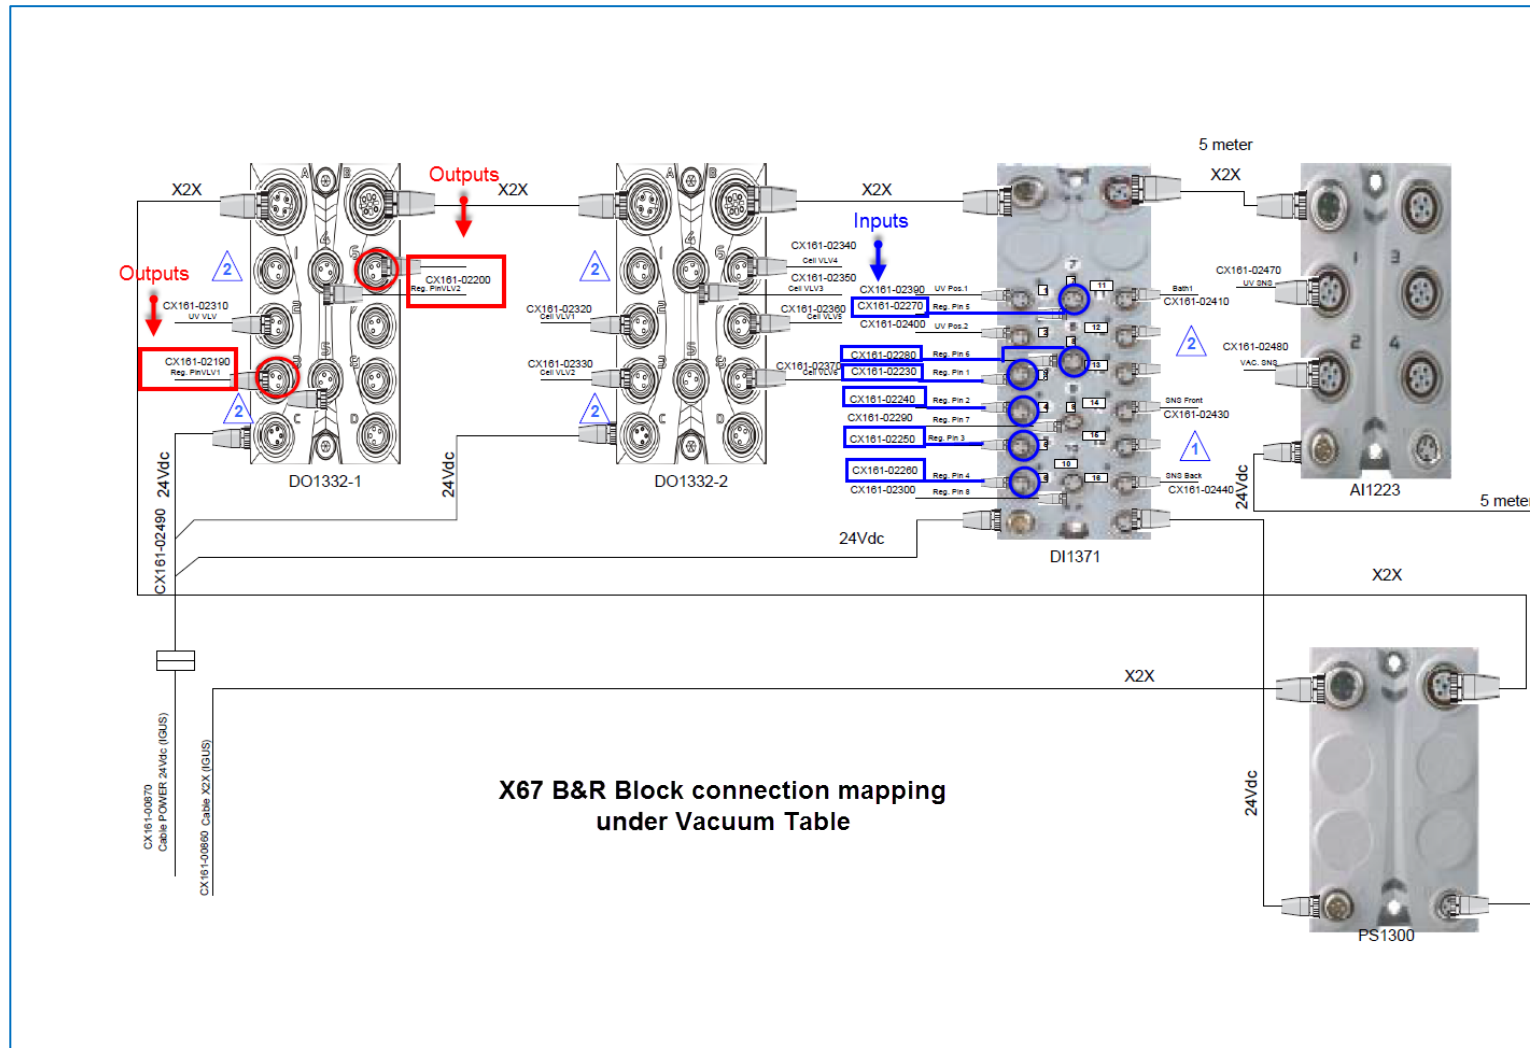
A cable along the wiring path from the sensor to the X67 B&R is disconnected

1. If the wiring path is ok then try replacing the sensor of the faulty positioning pin sensor.
2. If the error persists, continue to the next possible cause.

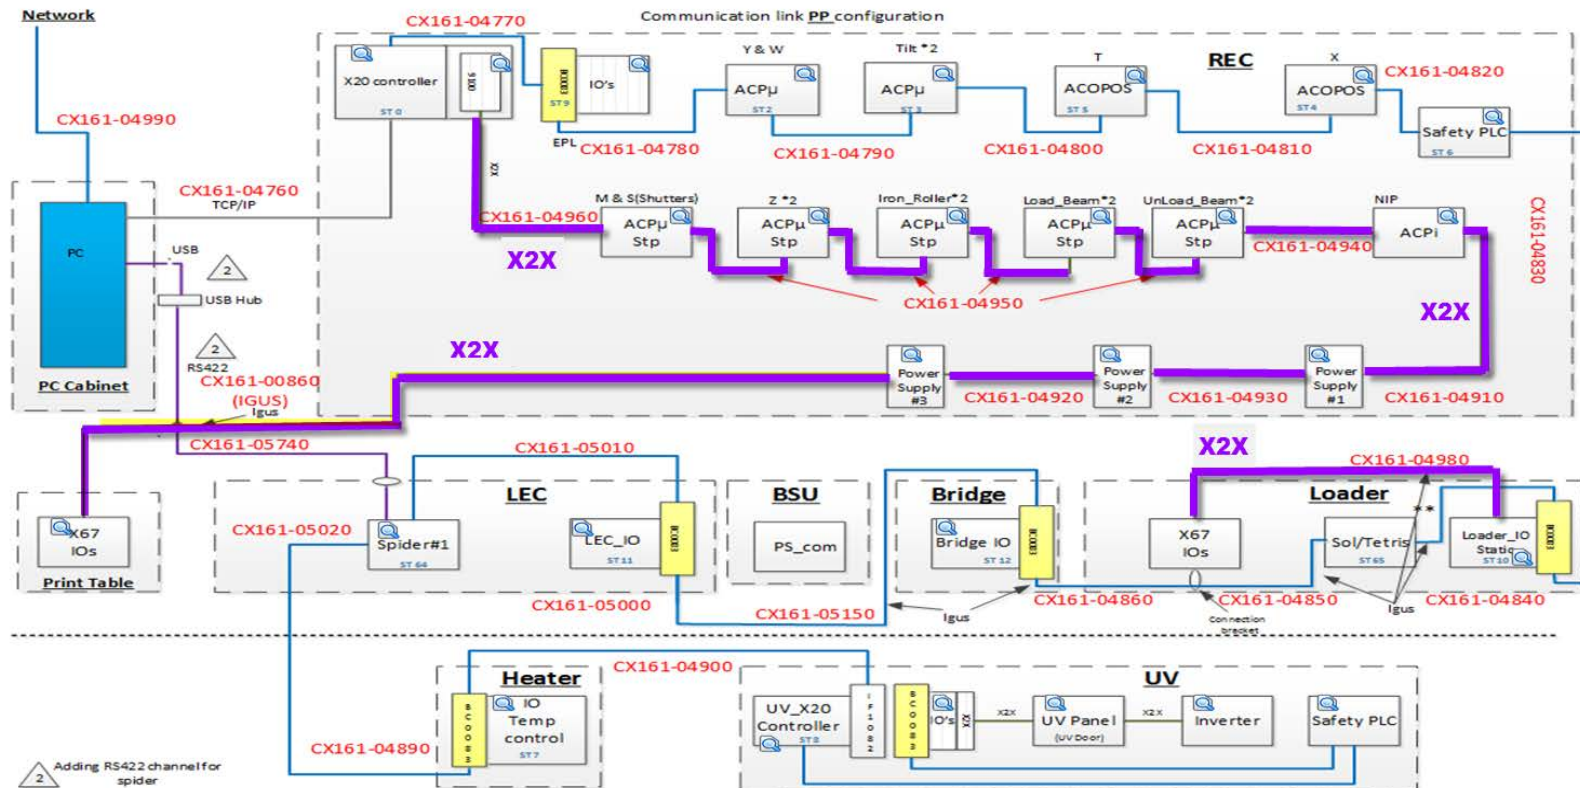
B&R Connections

The Ethernet X2X cable under the vacuum table to X67 B&R under table is disconnected

1. Inspect the X2X Ethernet cable (violet) path. Start from the X67 B&R block under the table as described in the diagram below. (A diagnostic test on the X2X connectivity has already been written and will be implemented in the coming months).

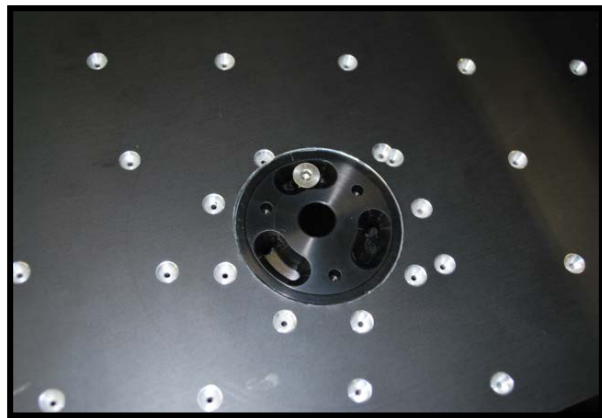
One of the positioning pins is damaged or obstructed

1. Inspect the pins for physical obstruction.
2. Inspect the pins for physical damage.
