## FB10000 Error Message Troubleshooting

### Error ID: 60065 – IDS – Unable to fill the Light Cyan secondary tank (timed out)

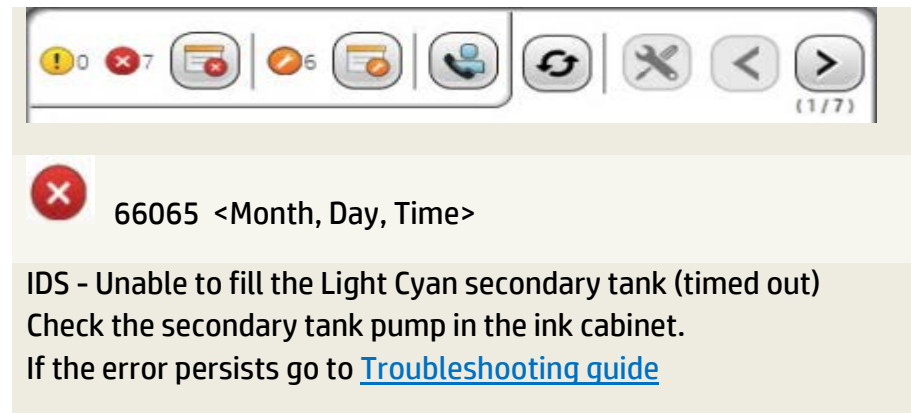
- [Light Cyan ink tubing to secondary ink tank is obstructed](#)
- [B&R did not send the command to the Light Cyan secondary tank feeding pump](#)
- [Light Cyan 5 micron ink filter is clogged](#)
- [Light Cyan secondary tank feeding pump is faulty](#)
- [Light Cyan 3 Way-switching valve is faulty](#)

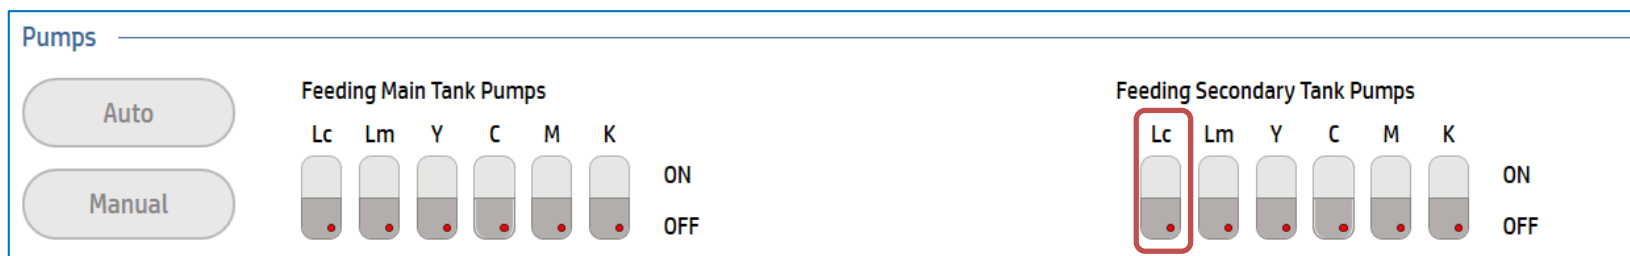
### B&R did not send the command to the Light Cyan Feeding Secondary Tank pump

1. In Control Tools, activate the Light Cyan feeding ink command.

2. Check if the secondary tank feeding pump received the command and started feeding ink.
3. If no command reached the pump, check the B&R or the wiring path for failure.
