FB10000 Error Messages Troubleshooting

Error ID: 200020 – Datapath – DataEngine: Etherway cards are in simulation mode.

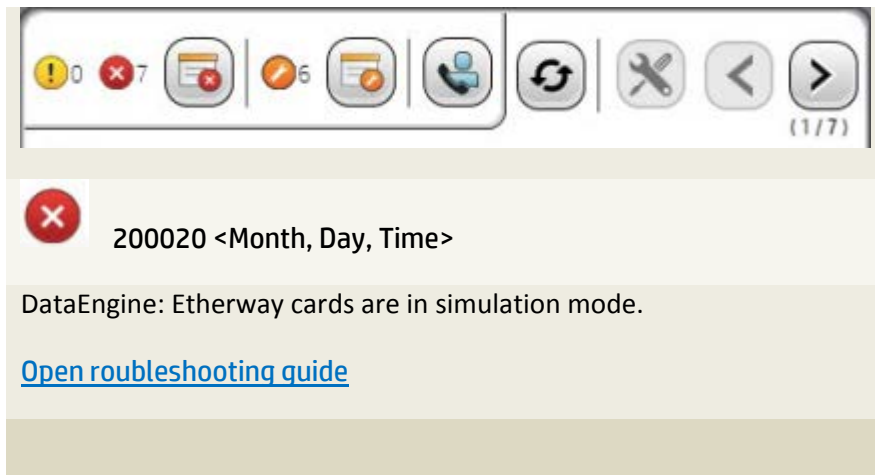
Error Message:

Possible Causes

- Simulation mode for Etherway was activated.

1. Exit the application and open Windows Explorer.
2. Under `ProgramData>HP Scitex>FB10000>Version_0.xx.xx>Configs`
3. Backup the file.
4. Open `DataEngineSettings.XML`
5. Find `<IsSimulationModeEtherway>True</ IsSimulationModeEtherway>`
6. Turn `True` to `False`
7. Restart application.
8. If the error persists restore the original file and repeat procedure.
9. If the error persists, contact `callme@hp` for support and send corrupt configuration file.
