HP Designjet H-Series
HP Scitex FB950 Printer

Troubleshooting vacuum issues

Part number TN2807 Revision A

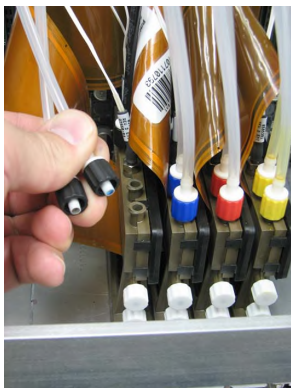
Figure 24 Both air tubes removed from a printhead in an H35100.

1. Disconnect both air tubes from the suspected reservoir(s) (see Figure 24).

3. If the reservoir(s) is the sole cause of the air leak, the vacuum status should quickly go back up to the normal range and the vacuum system should stabilize.

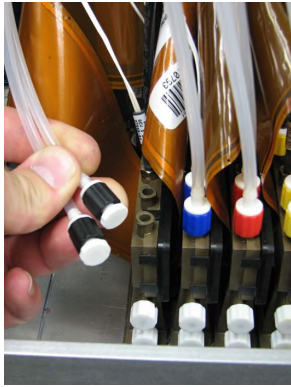
Figure 25 Both tubes capped with Luer plugs

2. If available, use Luer plugs to cap off both air tubes (see Figure 25); otherwise, use some other airtight method to seal off these tubes.

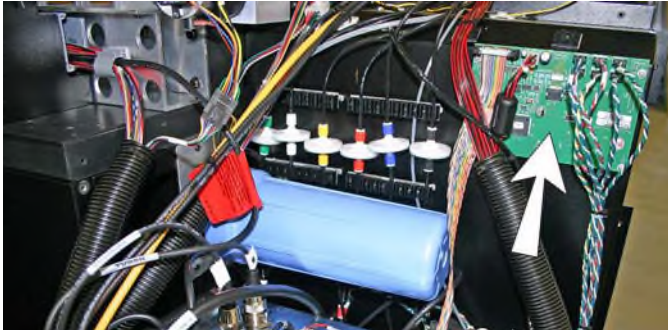
Figure 30 Vacuum reservoir or accumulator in H-series, visible at center. The board at the right is unrelated to the vacuum system.

A primary candidate for an unexpected opening is the seal at the blue vacuum reservoir. This component is located away from the vacuum assembly. The two flexible tubes (“B” and “C” in Figure 9 or “A” and “C” in Figure 10) lead from the vacuum assembly to the vacuum reservoir. The reservoir resembles a filter housing, but there no filter material contained inside it. See Figure 30 for the reservoir as it is found in the H-series; the location of the reservoir in the FB950 is visible at the upper left in Figure 10.

The blue canister should be securely twisted onto the black base and a rubber O-ring between the two pieces to create the seal. Generally the blue canister is very firmly screwed in place and may be difficult to remove. The seal does not have a history of spontaneous failure. The only real reason to suspect a problem in this area is if it is known that the blue canister was interfered with recently, which may include having removed the canister, thus potentially having lost the O-ring; or if the canister were reinstalled and over-tightened, causing the canister to crack.

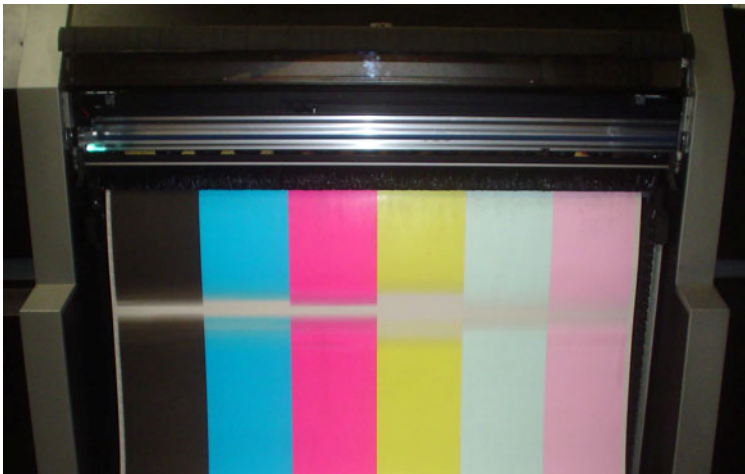
Figure 32 Output from H-series showing all colors fading away and then coming back

See section 2.3 regarding the restrictor. In this situation, the ink pumps run and disrupt the vacuum during printing. The vacuum does not recover quickly enough to prevent some ink from seeping out of the printheads and covering the bottom with a thin layer of ink. This thin coating of ink impedes the ability of the printhead to jet new drops, and so the color appears to fade away. As the vacuum slowly recovers, the ink seepage stops and the jets are eventually able print again.

Figure 32 shows an example of all colors being temporarily disrupted by a slow-recovering vacuum.

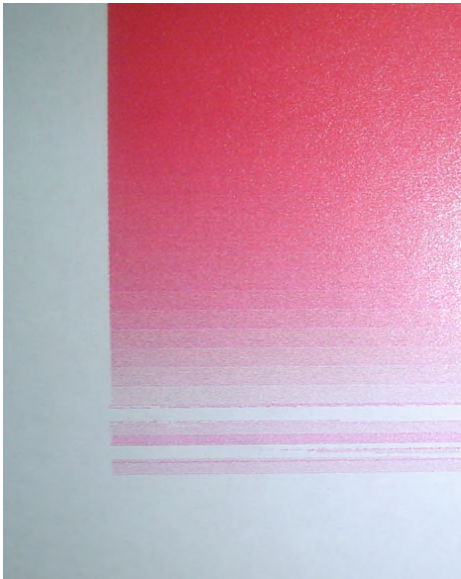
Figure 33 Detail of color coming back in following the drop out

Figure 33 shows in detail how the color gradually comes back. It is important to observe the distinction between an abrupt, total failure of all colors and this gradual failure. An abrupt failure, where the drop out is a clean break all at once, is not indicative of a vacuum failure, but of a problem with the power cable to the headboard. The gradual fade-out and return shown in Figures 32 and 33 indicates either a vacuum issue or an ink supply issue.
