Welcome to the 1st edition of the HP LaserJet Product Update Customer Newsletter—created for our most valuable HP partners and customers. Our intent is to provide you with “hot-off-the-press” technical information about the HP LaserJet printers that you use and support.

This issue provides firmware, software, and hardware updates for the many new HP LaserJet products we introduced in 2005. Let us know what other information would be valuable to you! Write to [ljnewsletter@hp.com](mailto:ljnewsletter@hp.com) and tell us what you think!

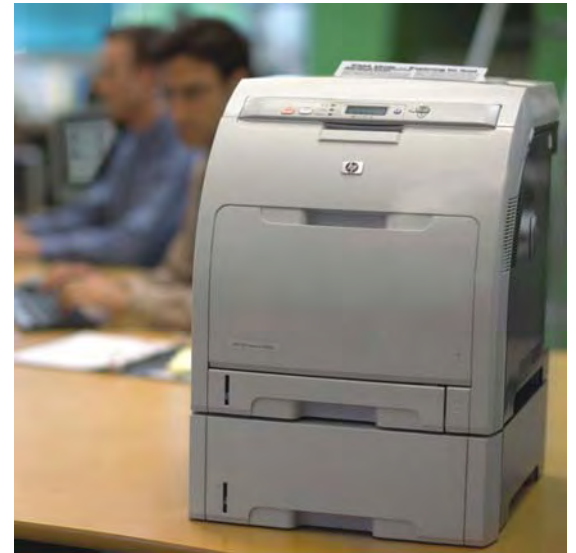
HP Color LaserJet 3000 printer

This cartridge locking tab is broken

1. Open and close the front door.
2. Reseat all the cartridges.
3. Power cycle the printer.
4. Look to see if the cartridge lock is broken or in place (see the photos below). If broken, or if steps 1 through 3 did not resolve the issue, contact HP Customer Care and reference document number C00642453.

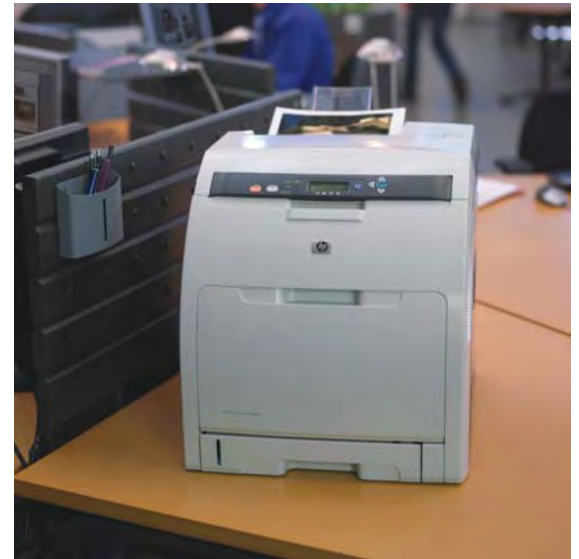
HP Color LaserJet 3600 printer

### Example of magenta band

The printer will require repair. Contact HP Customer Care and refer to document number C00642440.
