November  
2006  
Issue 2

Welcome to the 2nd edition of the HP LaserJet Product Update Newsletter—created for our most valuable HP partners and customers. Our intent is to provide “hot-off-the-press” technical information about the HP LaserJet printers you use and support.

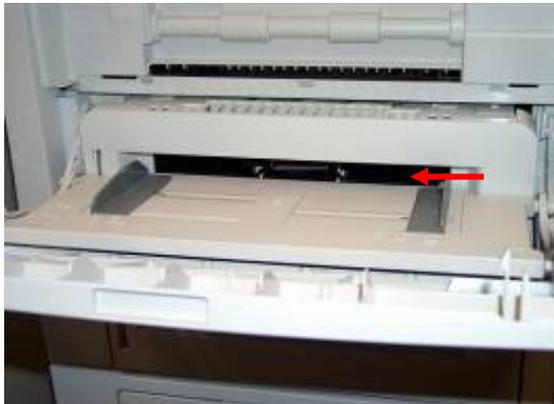
One possible cause for these errors is that the Tray 2 cassette shutter is not opening when Tray 1 opens. This shutter must open in order to allow paper to feed through the Tray 2 cassette when printing from Tray 1. (See the photos below.)

Tray 2 shutter open (correct)

Remove the front cover from Tray 2 and examine the shutter mechanism by following the steps in the next column.

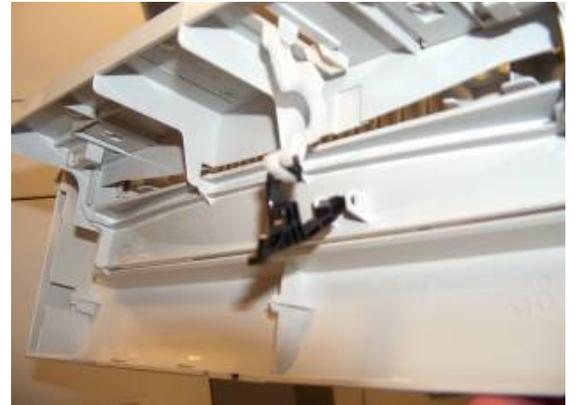
The shutter arm mechanism should move freely

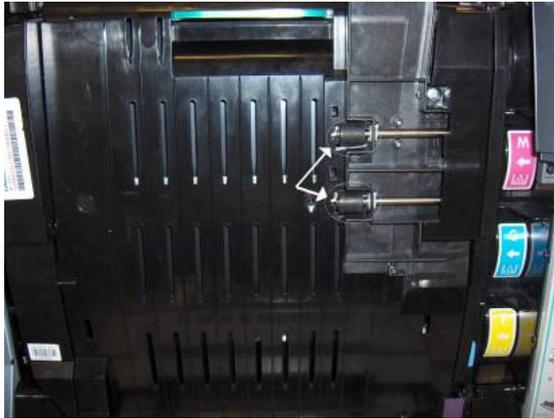
### Duplexer roller plate

Make sure the duplexer roller plate is installed on the back of the ETB. Duplex printing cannot be performed without the duplexer roller plate. Verify that the plate is sitting flush to the ETB and not out like the photo top, right.

Make sure the duplexer roller plate is installed on the back of the Electrostatic Transfer Belt (ETB). Check to ensure there are no gaps between the rollers. See the photo below, and top, right.

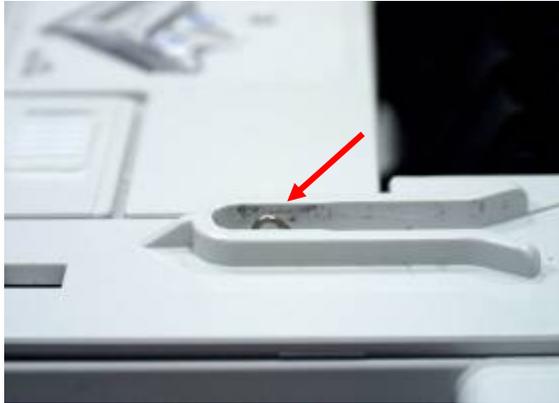
- Place the printer on a sturdy, flat, level surface and then try again to remove the tray.
- If Tray 2 is still stuck, “pull with authority,” with a slightly downward angle, if possible. Only attempt this if you feel confident and safe doing so.
- Inspect the cassette ground spring on the right side of the cassette. See the photos below to identify a “normal” or good spring versus a deformed or bent cassette grounding spring.

“Normal” or good grounding spring

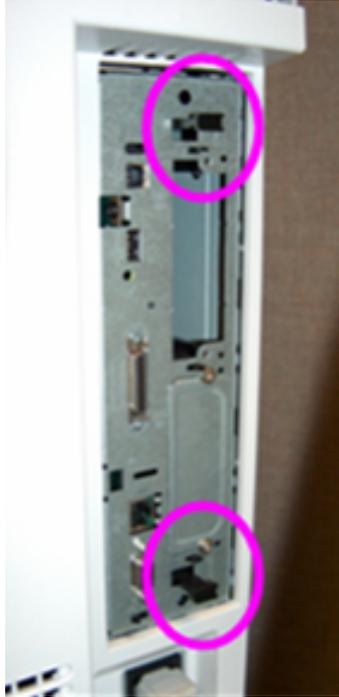
#### Correct position

In the photo above, the levers are in the outermost position (locked) and the formatter is recessed .25 inch (6–7 mm) from the side cover.

4. Power off, reseal the Compact Flash firmware card on the formatter, and retest.
5. Power off, reseal the memory DIMM on the formatter, and retest.
6. Power off, remove the memory DIMM from the formatter board, install in the other open memory DIMM slot, and retest. (If this does not resolve the issue, power off and put the memory DIMM back into the original slot.)
7. Note whether or not the “heartbeat” LED light on the formatter is lit or flashing at any time during power up.
8. If the Compact Flash firmware card has not yet been replaced, replace it with a new Compact Flash firmware card.
9. Replace the formatter. The part numbers are given in the next column.

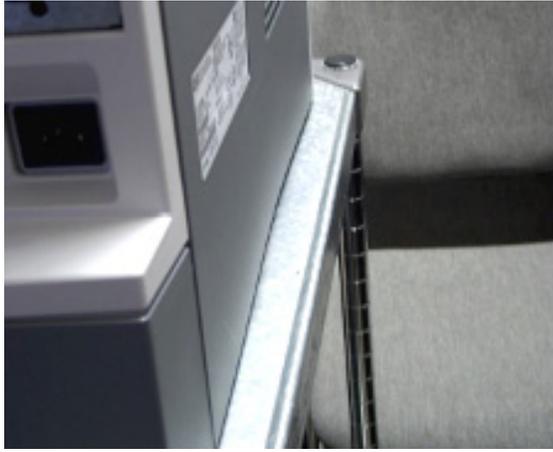
The printer may have experienced mild damage during shipment—for example, the rear crossbar on the chassis (behind Tray 2) may bow inward, pushing Tray 2 slightly forward and out of a completely inserted position. See the photos on the next page.

The rear cover normally bows slightly inward, but not as much as in picture below

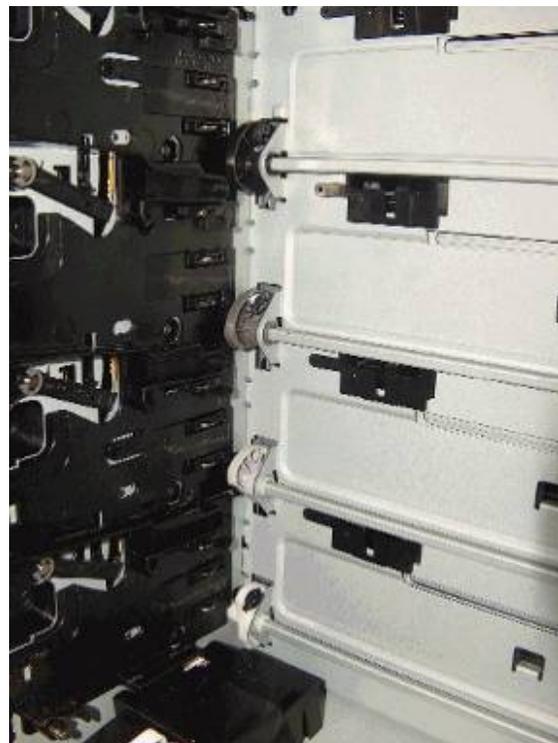
Secondary alienation cams are located on the Developer Alienation Cams. These secondary alienation cams are also called SCIP cams, where SCIP stands for Ship Cartridges In Printer. The sole purpose of these cams is to further alienate the cartridges during shipment. At first power-on out of box, a secondary alienation (SCIP) cam “roll over” process occurs in order to rotate the cams out of the way. This process occurs only once—during installation—and will not occur again once completed. The photo at the top of the next column shows how the Developer Alienation Cams should appear after a successful roll over of the SCIP cams. Note that the Developer Alienation Cams are “phase” offset, where the top cam appears to be rotated to the 6 o’clock position, the Magenta cam rotated to the 8 o’clock position, the Cyan cam rotated to the 10 o’clock position and the Yellow cam rotated to the 12 o’clock position. This is by design.

Left-side Developer Alienation Cams after successful secondary alienation (SCIP) cam roll over

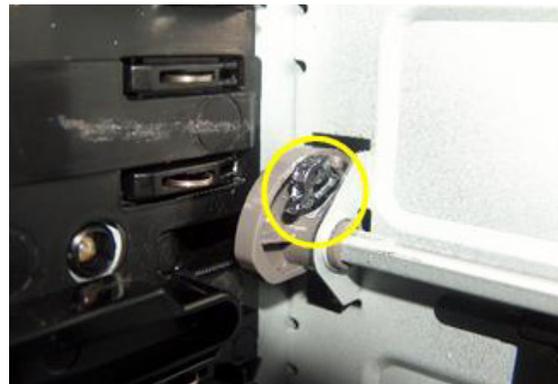
Occasionally, some units may exhibit a 59.C0 error on the control panel display but not experience a grinding noise. The solution is to rotate the SCIP cams out of the way to the “home” position on the Developer Alienation Cams. (See the photo below.)

How SCIP cams appear when in the “home” position

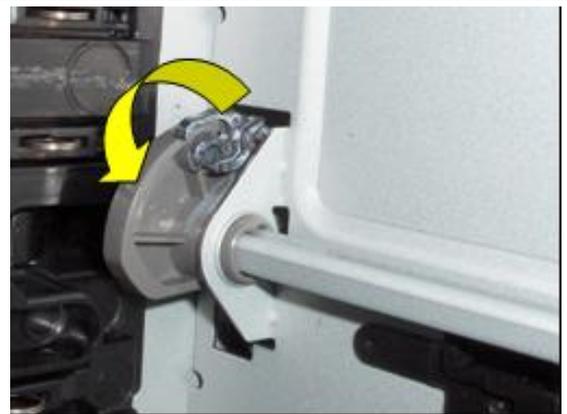
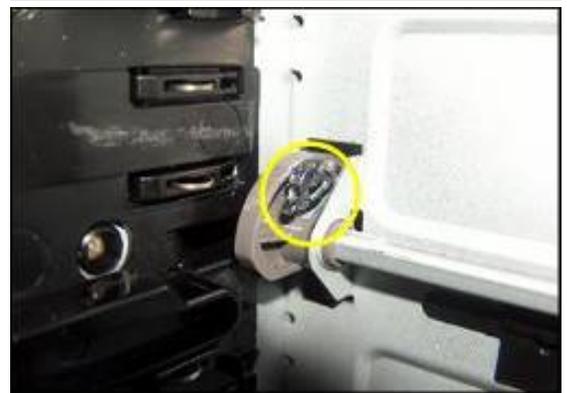
Photo #1 at right: Rotating the SCIP cam on the Developer Alienation Cam towards the front of the printer.

Photo #2 at right: The SCIP cam is rotated to the “home” (correctly seated) position.

6. When the SCIP cams pop through the sheet metal and are exposed, rotate the SCIP cams on the Developer Alienation Cam towards the front of the printer until the SCIP cams are seated in the “home” position as seen in the second photo on the right (circled yellow).
