November  
2007  
Issue 5

Welcome to the HP LaserJet Product Update Newsletter. We begin this newsletter with up-to-the-minute news concerning three critical product and process updates. They are highlighted here for your immediate attention:

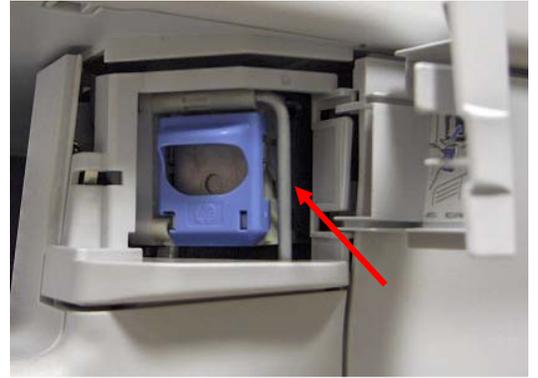
During transportation of the HP Color LaserJet M3035 MFP series, the stapler actuator rod frequently comes off. The stapler will not work and you may think it is broken. You may repair this yourself using the following instructions, or contact HP Customer Support for assistance.

The actuator rod is in its correct position

2. Verify that the stapler actuator rod is in the correct position.

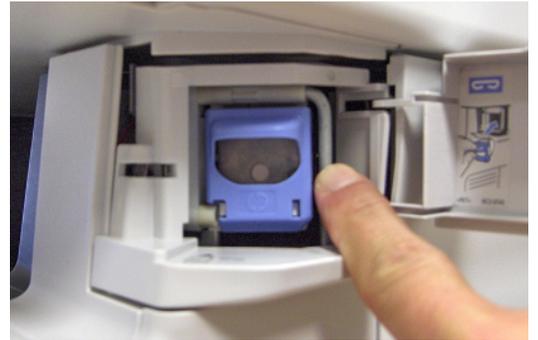
The actuator rod should move freely

3. Push on the stapler actuator rod. It has to move freely—you should feel a spring action when pushing the rod inwards.

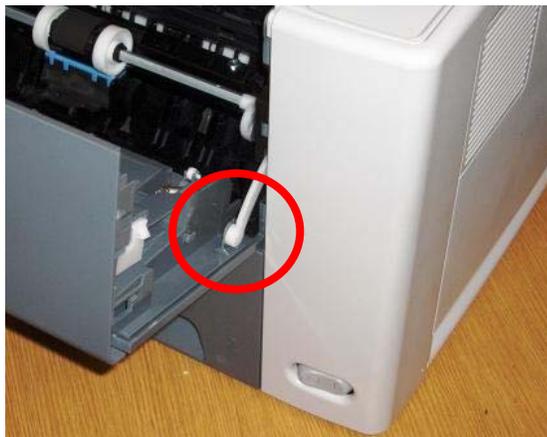
The photo below shows the plastic arm in the correct position.

### Correct position

1. Open the front cartridge door. Use needle nose pliers to grab the white plastic arm and insert it back into place (this can also be done by hand).
2. Verify that the plastic arm is installed properly by opening and closing the cartridge door and installing and removing the toner cartridge two or three times. The engine should run smoothly thereafter.
