February
2008
Issue 6

Welcome to the HP LaserJet Product Update Newsletter! Our featured articles, created in response to field and support partner requests, provide technical responses to UPD Frequently Asked Questions and a "BEST PRACTICES" for using HP LaserJet drivers in Microsoft® Cluster Server environments. Please keep sending your valuable comments and questions to ljnewsletter@hp.com.

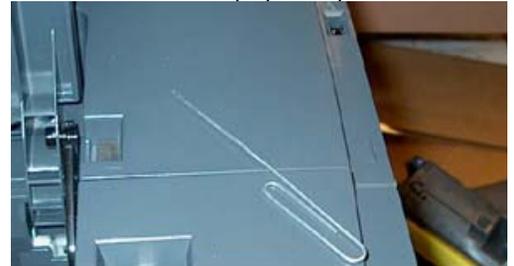
Create a carousel release tool

1. Remove the toner cartridges and the ITB/OPC drum. Store in a dry area with subdued lighting. Remove the toners from the printer with the power on, if possible. If no power is available, create a carousel release tool from a paper clip as shown:

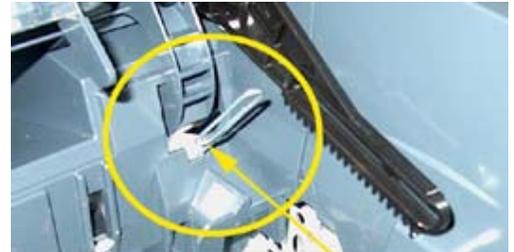
Insert the carousel release tool

Insert the carousel release tool into the slot as shown. Press in until a slight “click” is heard and the carousel rotates freely.

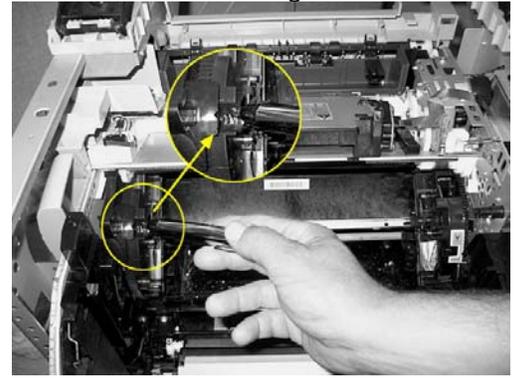
Rotate the slot into this initial position

- 12. Position the yellow cartridge slot. Insert the carousel release tool and rotate the carousel until the yellow toner label is pointed slightly toward the front instead of pointing straight up. Rotate the carousel back toward the rear of the printer from the top. A pen light will be helpful to see into the area where the gears mesh.

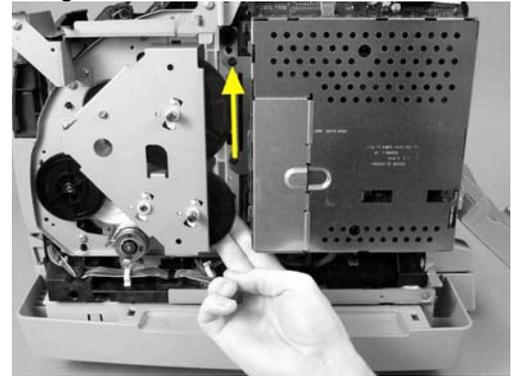
Reconnecting ITB/OPC link

16. When the black carousel gear recesses point between the alignment pins of the white gears on both the left and the right sides at the same time, reassemble the printer in the reverse order of disassembly. When reassembling the top cover, the ITB/OPC link arm may move out of position, preventing alignment of the link gear with the top cover arm. From the right side of the printer, just in front of the formatter, place a finger at the bottom of the link arm and push it to the top. This will put the gear shaft on the inside of the printer in the correct position to receive the link gear.
