FB10000 Error Messages Troubleshooting

Error ID: 50080: M-Handling – Manual loading pins are unable to go down

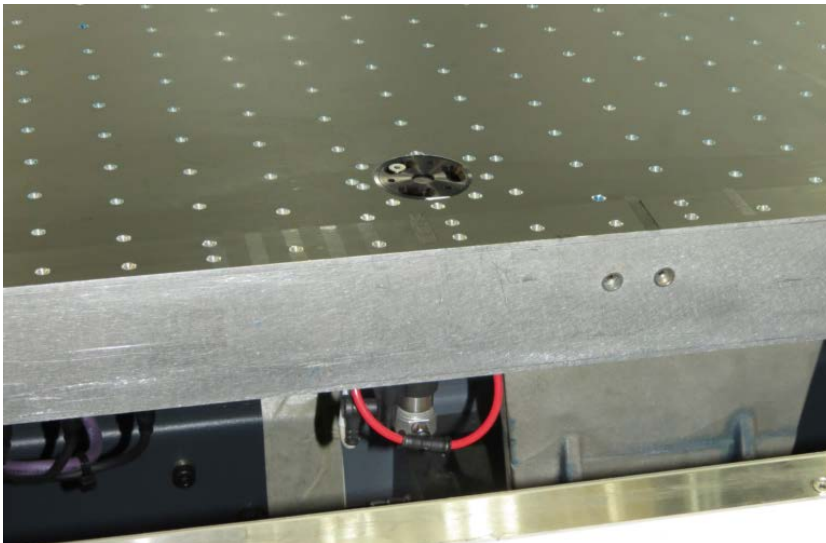
Possible Causes

This error may be triggered due to one of the following electronic, mechanical or communication failures.

- [One of the loading pins sensor is disconnected or faulty](#)
- [A cable along the wiring path from the sensor to the X67 B&R is disconnected](#)
- [One of the valves under the table is faulty](#)
- [The pneumatic panel does not supply the appropriate air pressure to the valves](#)
- [One of the pins is damaged or obstructed](#)
- [The Ethernet X2X cable under the vacuum table to X67 B&R under table is disconnected](#)
