## FB10000 Error Message Troubleshooting

### Error ID: 60065 – IDS – Unable to fill the Light Cyan secondary tank (timed out)

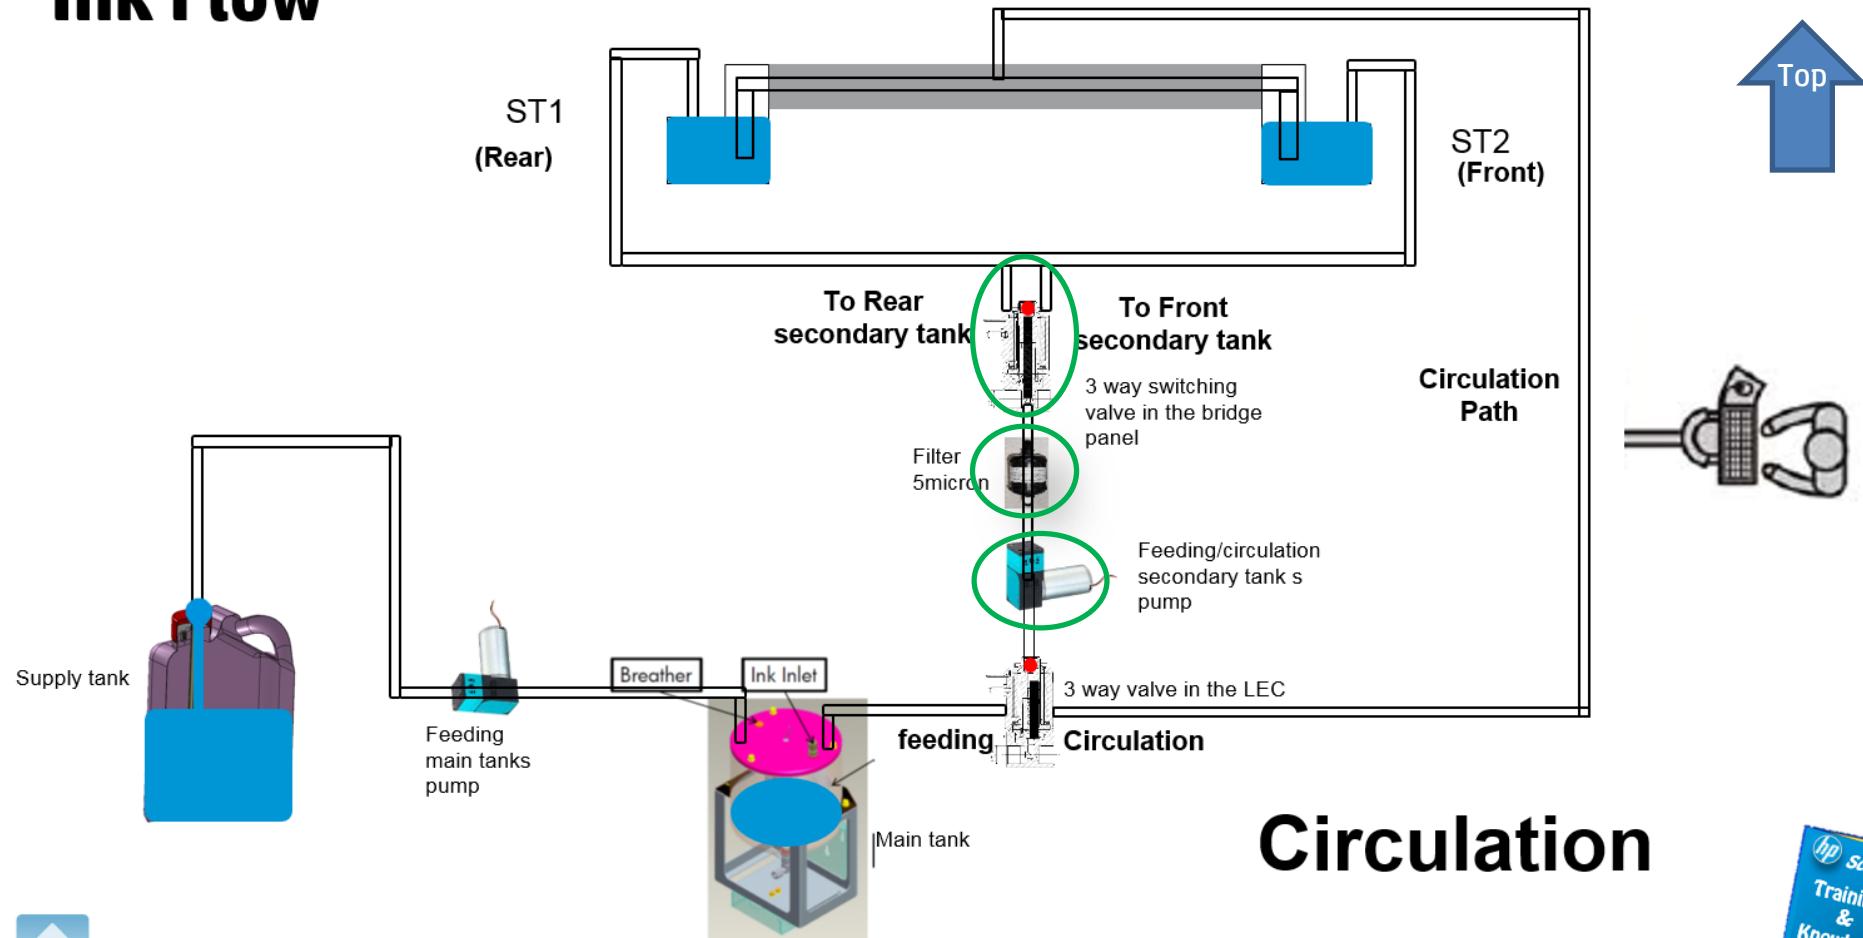
# Ink Flow

- [Light Cyan ink tubing to secondary ink tank is obstructed](#)
- [B&R did not send the command to the Light Cyan secondary tank feeding pump](#)
- [Light Cyan 5 micron ink filter is clogged](#)
- [Light Cyan secondary tank feeding pump is faulty](#)
- [Light Cyan 3 Way-switching valve is faulty](#)

1. Inspect the tubing along the route of the Light Cyan ink from the Main ink tank to the secondary tank.
2. If any Light Cyan tubing is bent or damaged, repair it.
3. If no Light Cyan tubing is bent or damaged, check the Light Cyan 5 micron ink filter.
