October 2006
Issue 32

Welcome to the 32nd edition of the HP LaserJet Product Update Newsletter—created for our most valuable HP partners and customers. Our intent is to provide “hot-off-the-press” technical information about the HP LaserJet printers you use and support.

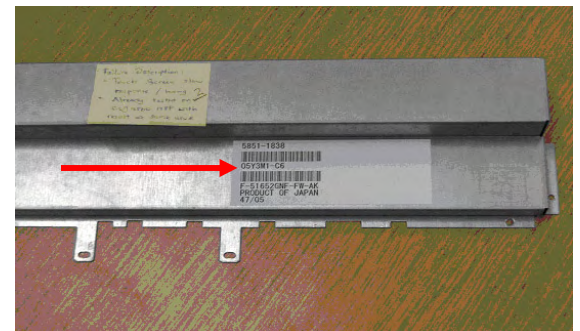
HP has isolated the issue to a combination of two elements: the ESD (Electrostatic Discharge) design and a specific lot code of Mylar used inside the touch screen. Both of these elements have been corrected by our supplier.

To find the serial number, look on the second line of the label (see the photo below) or on the rear of the control panel. The serial number in the photo below is 05Y3M1-XX.

Locate the serial number on the second line

Replace the control panel ONLY if the serial number identifies it as being defective.

Turn the printer's power off overnight to limit the failure. Even if the control panel is "locked up," powering-off overnight will reset it.

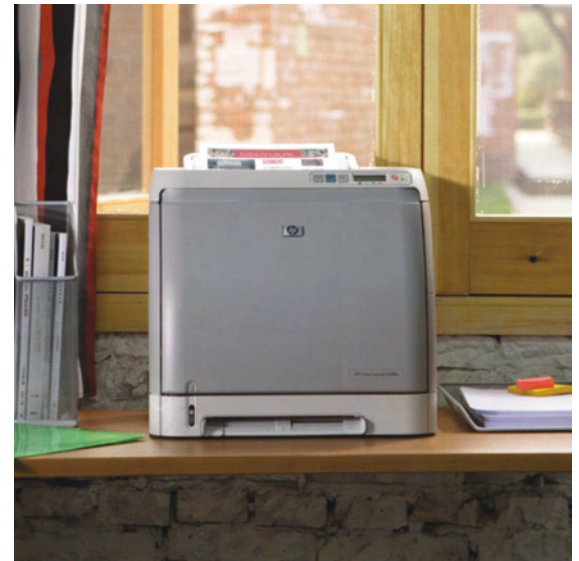
HP Color LaserJet 2600n printer

These bands are caused by damage to the Organic Photo Conductor (OPC), creating an electrical “leak” in the drum on one of the print cartridges. Because the OPCs for all four cartridges share a common power supply, when one of the OPCs is damaged, the defect shows up on all four colors. You can identify the damaged cartridge by a color smear on the line associated with the cartridge. For example, damage to the black cartridge can be identified by a black smear on the black line of the page. See the example below.

The damaged cartridge should be replaced. It is not necessary to replace all four cartridges. Determine which cartridge to replace by locating the smear on the line.

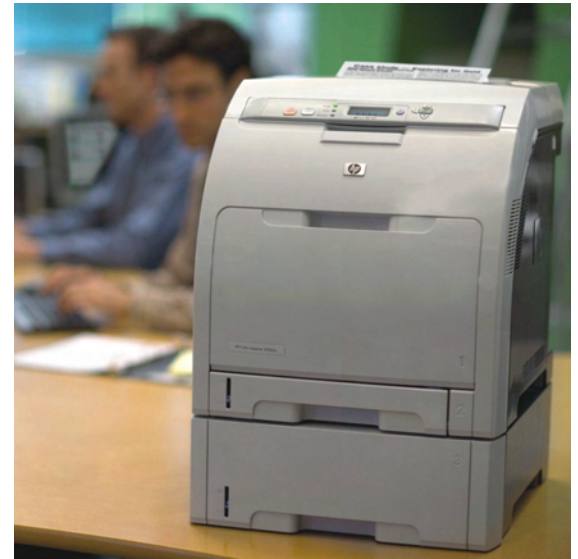
HP Color LaserJet 3000 printer

- Reseat all the cartridges.
- Check for a broken part that controls the movement of the cartridge engagement arm, the cartridge shutters, and the Organic Photo Conductor (OPC) drive (see the photos below). The first photo shows where the break occurs. The second photo shows where this part is located. You can easily check this without taking off the covers by reaching over to the white rod arm on the right hand side of the ETB, and wiggling it. If it moves easily, the part is broken. Replace with part number RC1-6645-000CN.

Area where break occurs

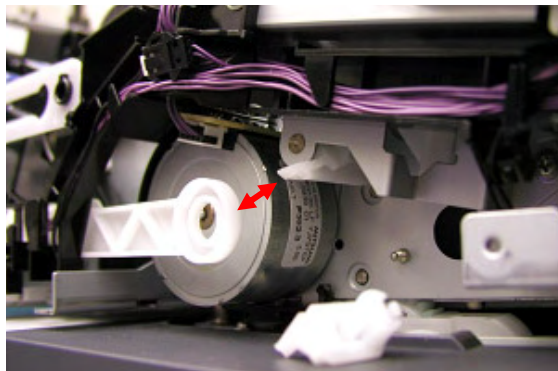
Part location

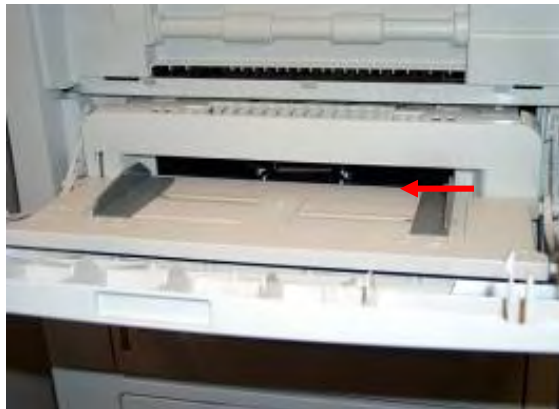
Tray 2 shutter open (correct)

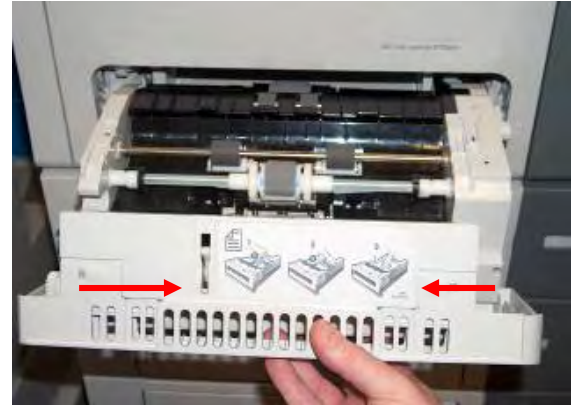
Removing the front cover from Tray 2

1. Remove the front of the tray by pushing the white retaining clips on top of the cassette toward the center of the tray, and then pull the top-front of the tray towards you. See the photo below.

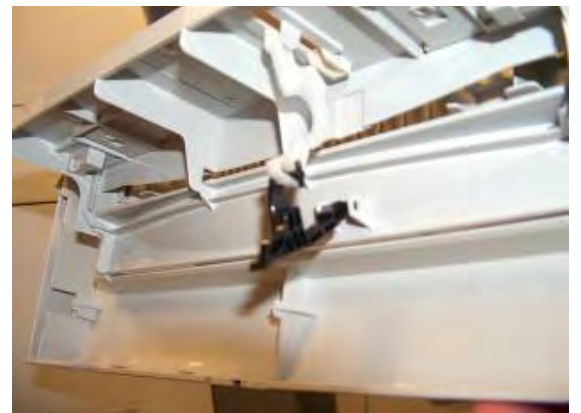
The shutter arm mechanism should move freely

2. The shutter arm mechanism should look like the photo below and move freely to open and close the shutter.

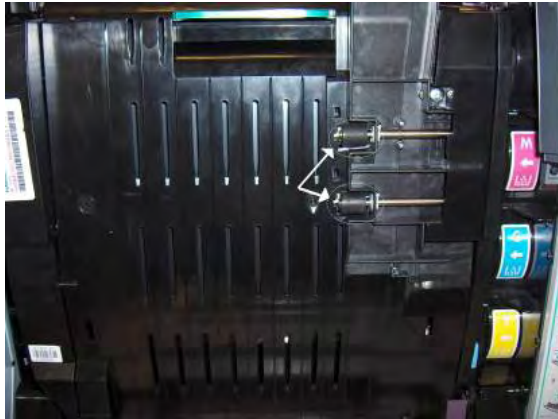
Location of the duplexer roller plate

Make sure the duplexer roller plate is installed on the back of the Electro Transfer Belt (ETB). Check to make sure there are no gaps between the rollers. See the two photos below, and top-right.

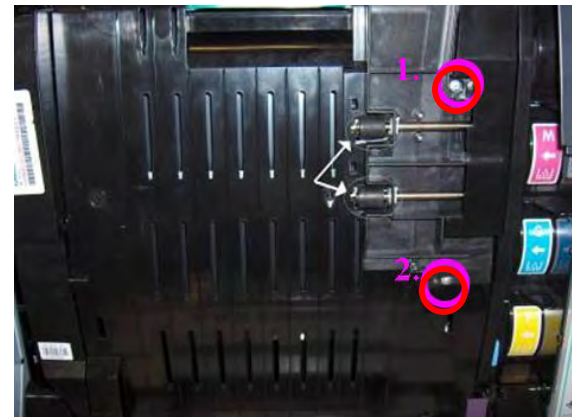
Location of ETB duplex guide screws

Screw the ETB duplex guide tight. The top screw may be loose. If you need to reinstall, remove the guide, then reinstall in the following manner:

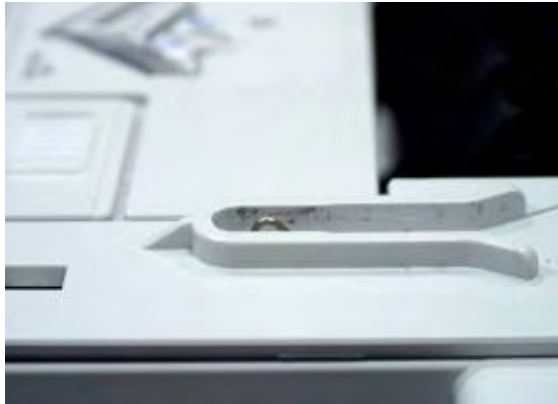
“Normal” or good grounding spring

Ask the customer to inspect the cassette ground spring on the right side of the cassette. See the photos below to identify a “normal” or good spring versus a deformed or bent cassette grounding spring.

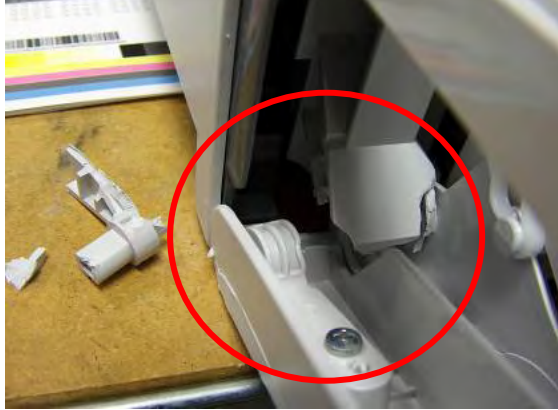
Open the front door and inspect the right hinge.

Replace the printer.

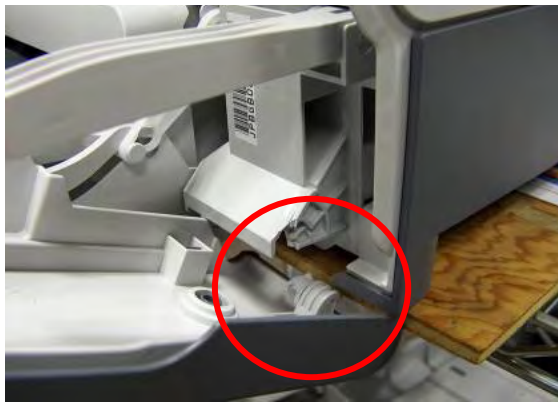
Inspect the exit roller area (if ph+, remove the stapler/stacker).

Replace the printer.

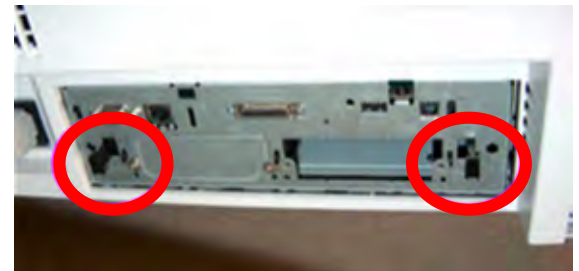
Correct

In the photo above, the levers are in the outermost position (locked) and the formatter is recessed .25 inch (6–7 mm) from the side cover.

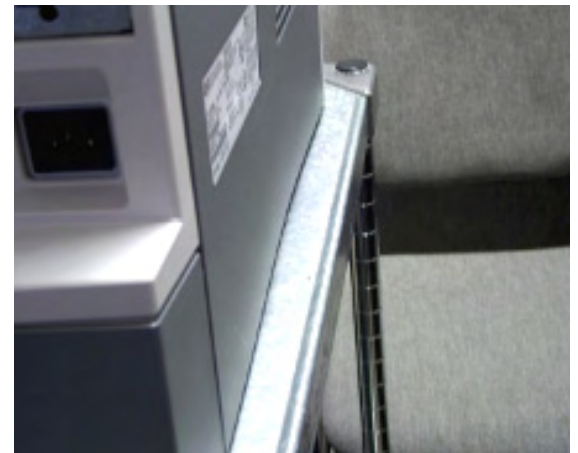
The printer may have experienced mild damage during shipment—for example, the rear crossbar on the chassis (behind Tray 2) may bow inward, pushing Tray 2 slightly forward and out of a completely inserted position. See the photos below.

The rear cover normally bows slightly inward, but not as much as in picture below

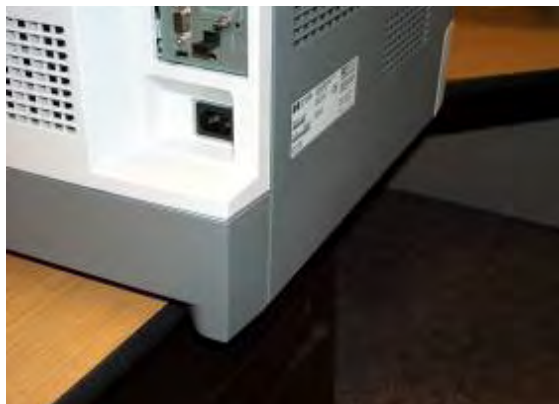
Position the printer

1. Remove Tray 2.
2. Position the rear of the printer over the edge of a flat, stable surface to provide access to the area behind Tray 2.
3. Reach under and behind the rear cover, feeling for the metal crossbar.
4. Using the other hand or shoulder to brace against the printer, carefully pull the crossbar outward, being VERY careful to keep the printer from sliding off the table. See the photo below.

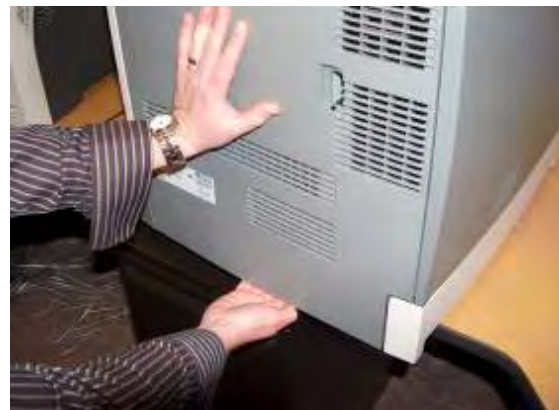
Pulling the crossbar straight

5. Use one hand to press against the rear of the printer and the other to pull the crossbar straight. See the photo below.

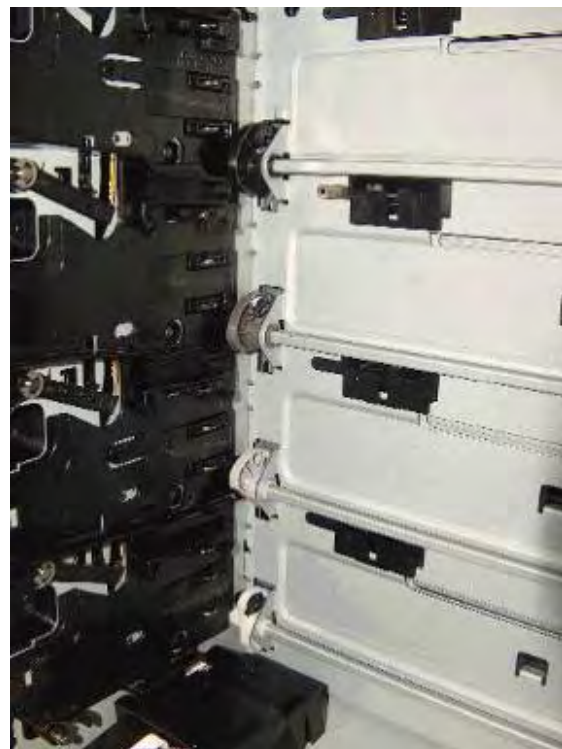
Secondary alienation cams are located on the Developer Alienation Cams. These secondary alienation cams are also called SCIP cams. SCIP stands for Ship Cartridges In Printer. The sole purpose of these cams is to further alienate the cartridges during shipment. At first power on out of the box, a SCIP cam “roll over” process occurs in order to rotate the cams out of the way. This process occurs only once—during installation—and will not occur again once completed. The photo below shows how the Developer Alienation Cams should appear after a successful “roll over” of the SCIP cams. Note that the Developer Alienation Cams are “phase” offset. The top cam appears to be rotated to the 6 o’clock position, the Magenta cam rotated to the 8 o’clock position, the Cyan cam rotated to the 10 o’clock position and the Yellow cam rotated to the 12 o’clock position. This is by design.

Developer Alienation Cams after successful SCIP cam roll over

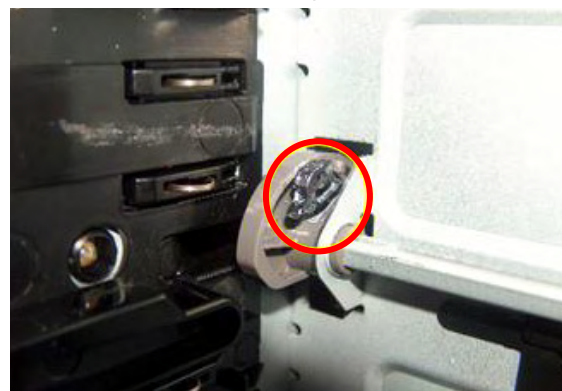
Rotating SCIP cams out of the way

Some units may exhibit a 59.C0 error on the control panel’s display but not experience a grinding noise. The solution is to rotate the SCIP cams out of the way on the Developer Alienation Cams. See the photo below.

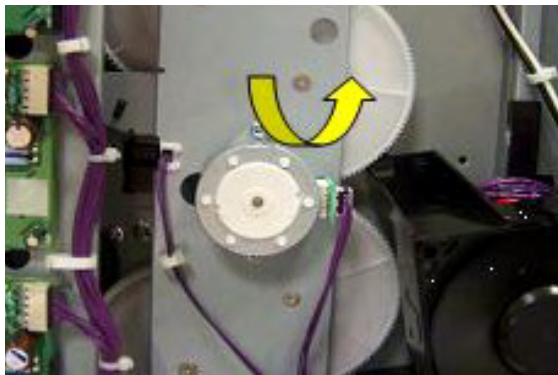
Rotate counterclockwise

1. Power up and verify the 59.C0 error message and pulsing/grinding noise.
2. Open and remove the ETB and four cartridges.
3. Check the Developer Alienation Cam position and verify that the SCIP cams are not visible after unsuccessful "rollover."
4. On the HP Color LaserJet 4700, remove the right side cover. On the HP Color LaserJet 4730 MFP, remove the rear cover.
5. Manually rotate the Developer Drive Alienation Gear in the *counterclockwise* direction until the SCIP cams pop through the sheet metal hole.

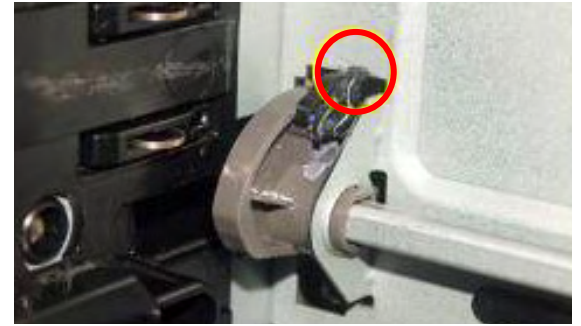
Be sure the SCIP cams pop through the sheet metal hole

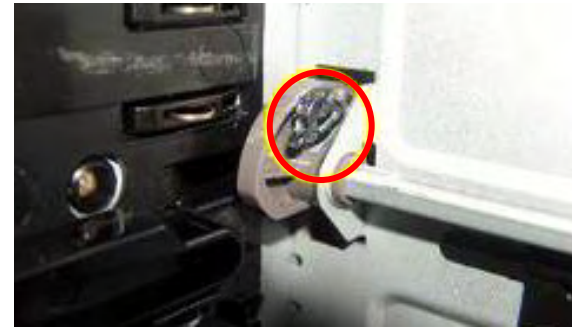
Verify that the SCIP cams have been rotated out of the way

6. Manually rotate the Developer Drive Alienation Gear in the *clockwise* direction for two full 360° rotations. Verify that the SCIP cams have been rotated out of the way on the Developer Alienation Cams, as pictured below.
