HP Latex 3x00 Printer Series

TECHNICAL NEWSLETTERS FROM CUSTOMER ASSURANCE

New FW, IPS, Print Care, HP Info Retriever packages available – MR7

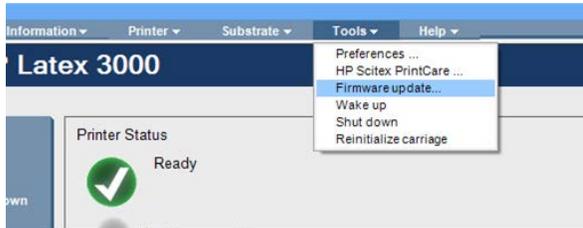
- a. Download the **ALTAMIRA_09_01_04.1.zip** file and extract the **.fmw** file.
- b. In the IPS application, select **Firmware update** from the **Tools** menu.

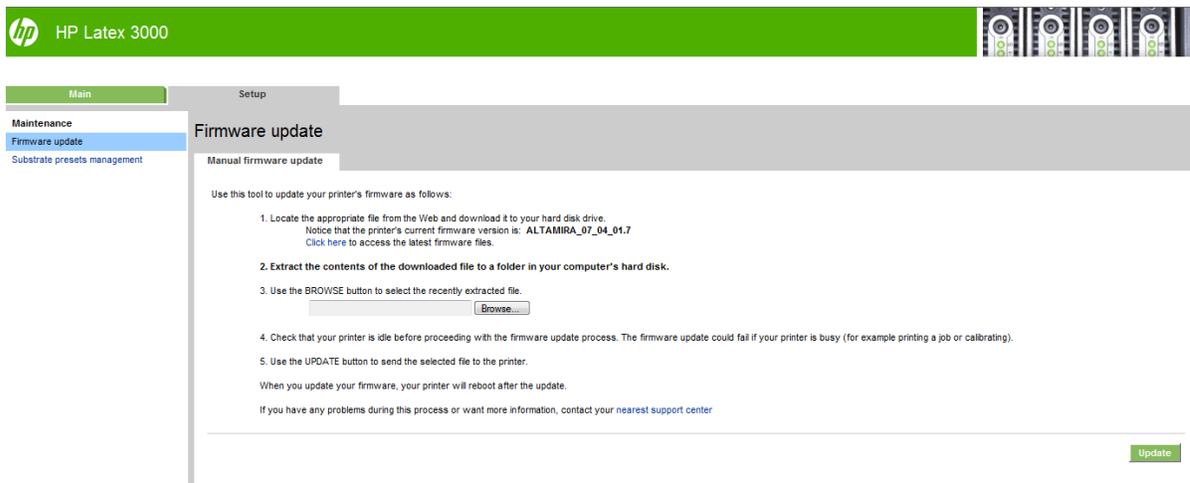
- c. In the Embedded Web Server, browse to select the '**ALTAMIRA_09_01_04.1.fmw**' file, and click the **Update** button.

Firmware installation takes about 20-30 minutes. Do not touch anything, the printer will reboot after installation without any interaction. If it does not, reboot the printer.

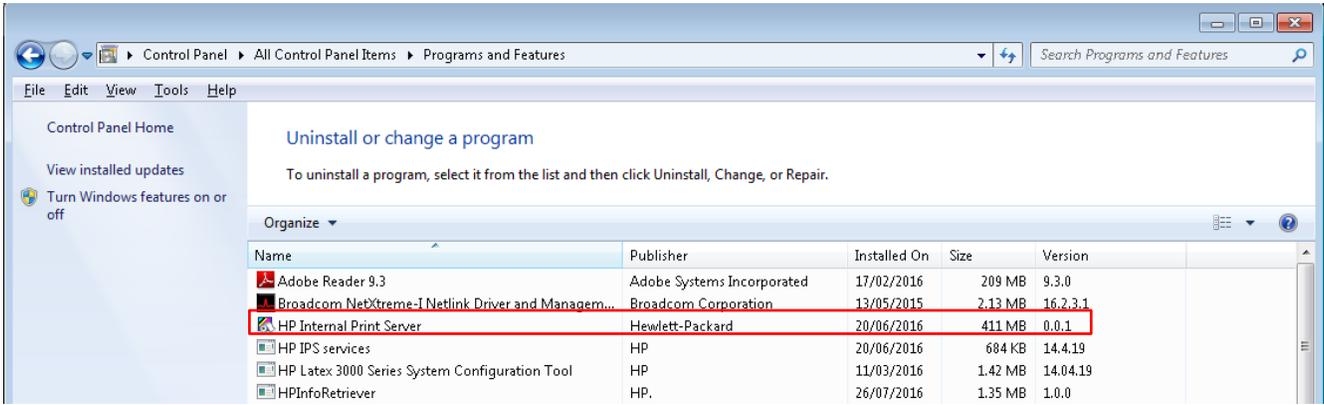
- a. Download the **v2014.4.24.5** zip file onto the IPS PC hard disk (recommended on a dedicated folder, not on the desktop) and unzip all the files.
- b. Remove the Internal Print Server software through the Windows control panel. Select Uninstall Internal Print Server Application.

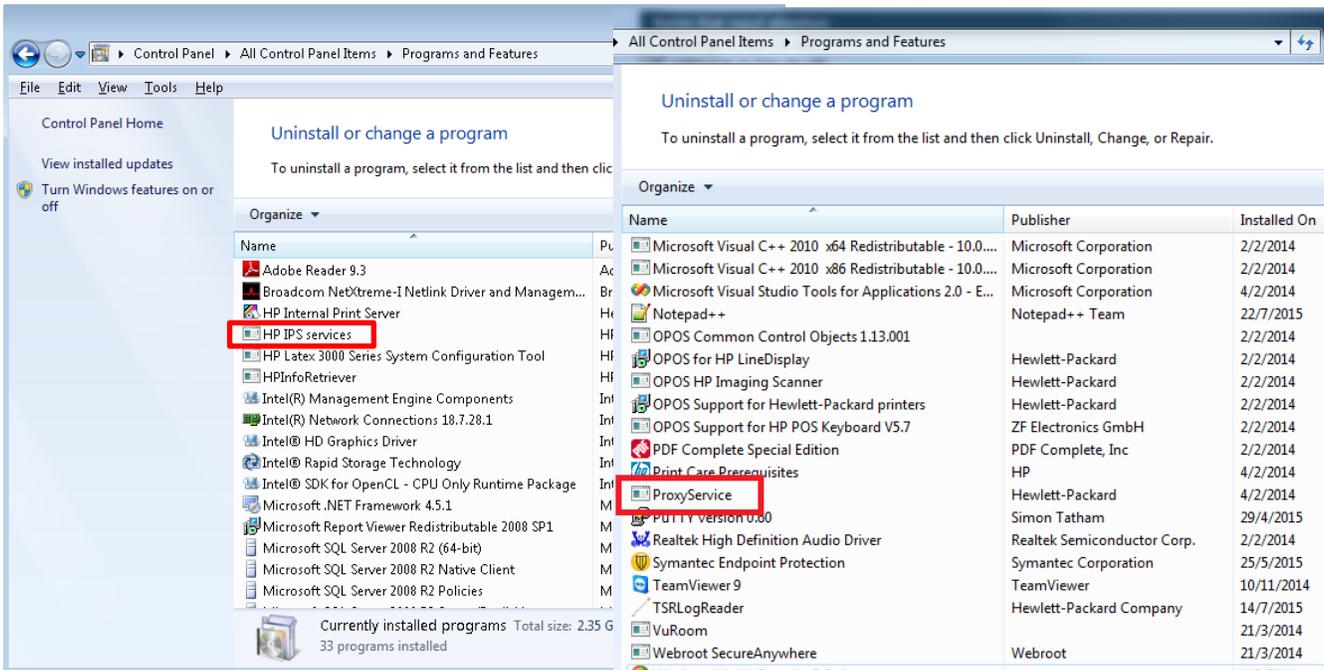
c. Remove the “HP IPS Services” and/or “ProxyService” software through the Windows control panel.

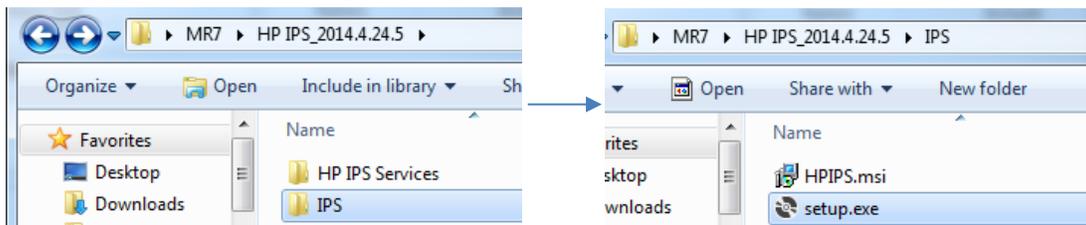
d. Install the HP Internal Print Server (IPS).

Run the **setup.exe** file located inside the **IPS** folder and follow the onscreen instructions until the new software is installed.

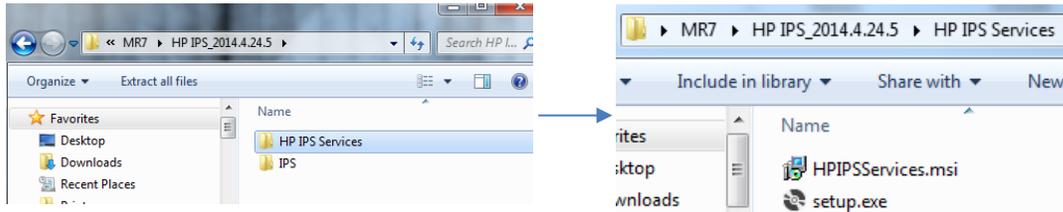
- e. Install HP IPS Services.

Run the **setup.exe** file inside the **HP IPS Services** folder and follow the onscreen instructions until the new software is installed.

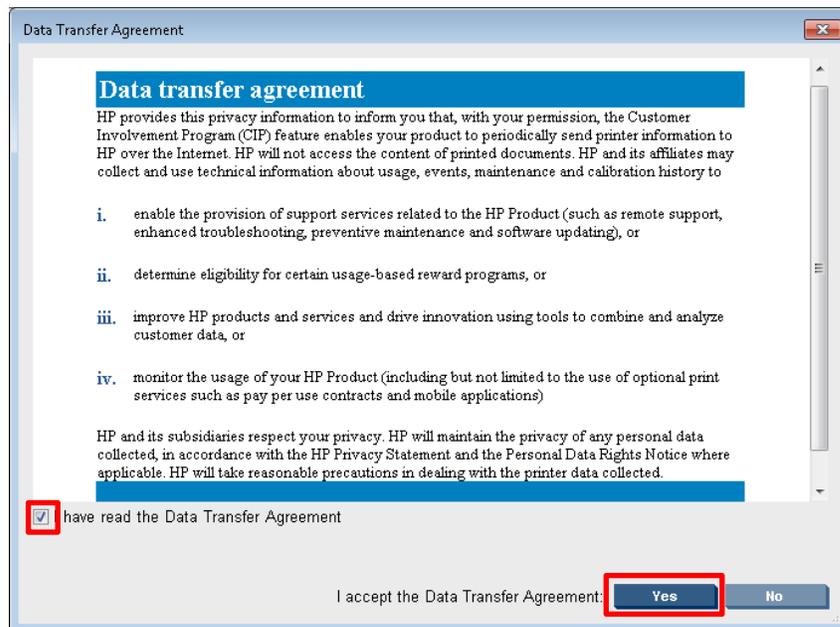
- f. Once the installation process of IPS is completed, open the IPS application. At first boot, the Data Transfer Agreement (DTA) will appear. We strongly suggest to enable it in order to take advantage of the info retriever functionalities and of a faster and better remote support.

IMPORTANT: To be able to use the Info retriever functionalities and take advantage of a faster and better remote support, the DTA from the HP IPS software must be accepted (see point 2.f above for further details).

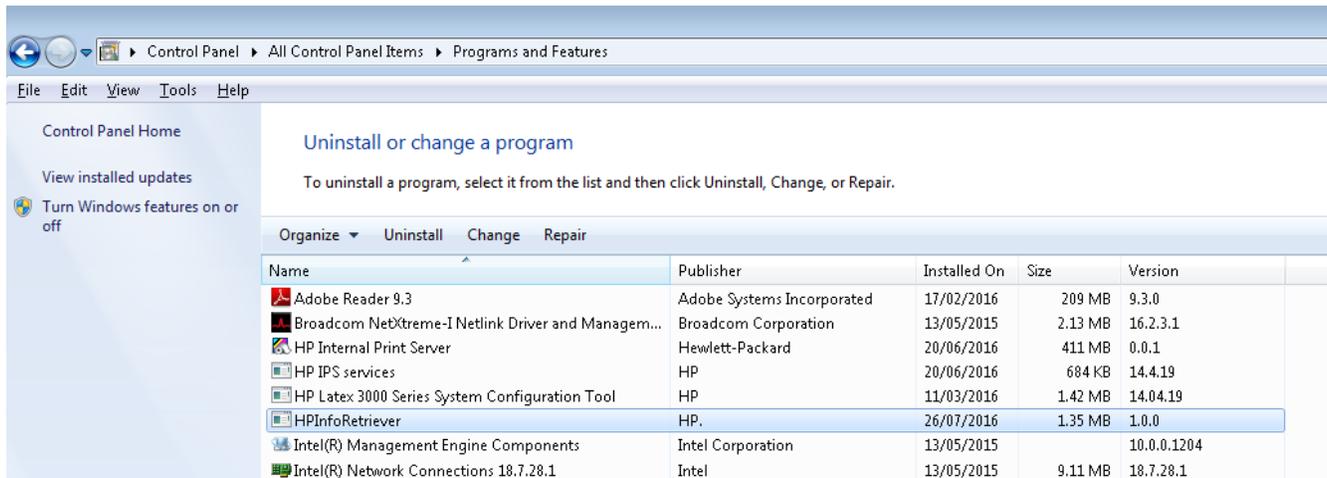
- Download **HPInfoRetriever v2.3.3.0.zip** and extract all the files.
- Uninstall previous versions through the Windows control panel.

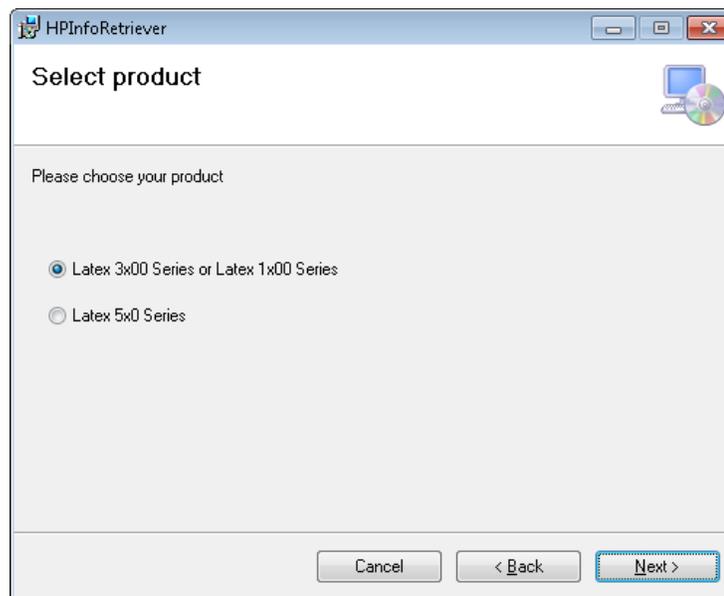
- Run **setup.exe**, choose **Latex 3x00 Series** as a product, and follow the onscreen instructions until the new software is installed.

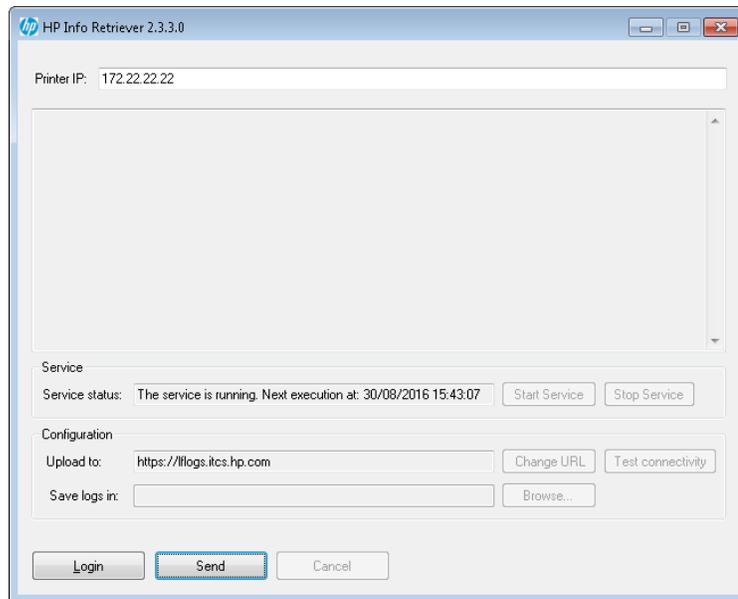
- Once the HP Info Retriever application is installed, click on **Send** in order to do the first connection. Printer must be IDLE.

The “**Uploading logs completed**” message will be displayed if the process succeeds without any error.

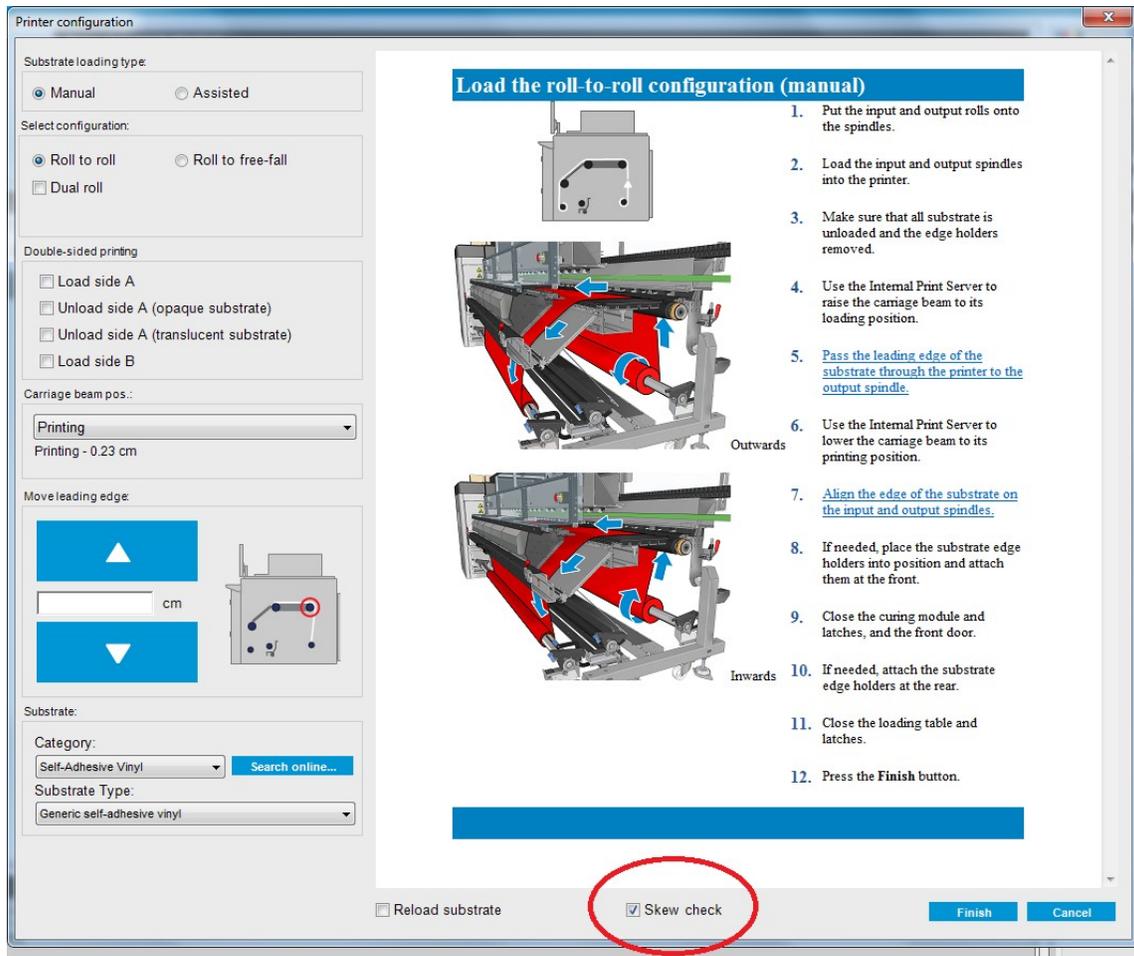
This feature will not tell the customer whether the media is properly loaded or not, but it will provide the amount of lateral movement during the load. Every customer, with expertise, may set a threshold for each media type.

This option can be selected through the Printer Configuration window during substrate loading.

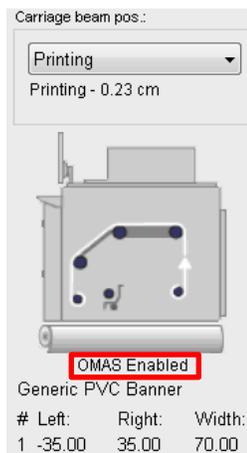
- **OMAS status** can be checked on the HP IPS application.

Note: The OMAS status information on the IPS is not updated in real time. It is just refreshed when there is a change of state of the printer (carriage re-initialization, printhead replacement, printing a new job, etc.). In a next implementation, the status will be shown in real time.
